SERVICE BULLETIN

Classification:	Reference:	Date:
EC12-031	NTB12-108	November 28, 2012

2013 VERSA SEDAN WITH A/T; DELAYED THROTTLE RESPONSE AT ENGINE START

APPLIED VEHICLES: 2013 Versa Sedan (N17) – with 4-speed A/T ONLY

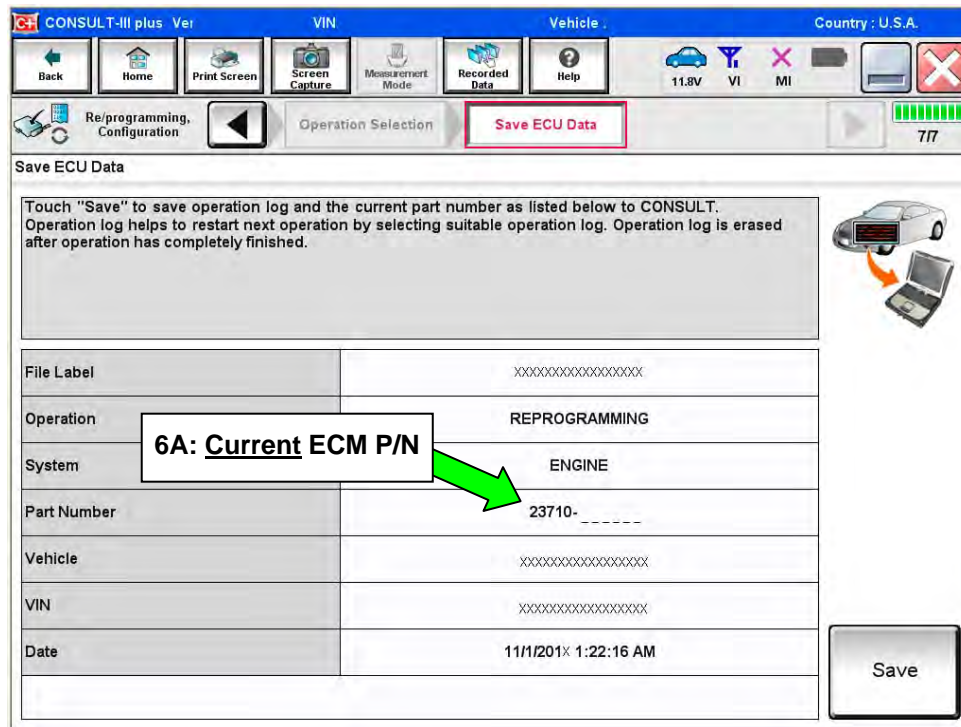
Figure 2

6. When you get to the screen shown in Figure 2, confirm this bulletin applies as follows.
- A. Find the ECM **Part Number** and write it on the repair order.

NOTE: This is the current ECM Part Number (P/N).

- B. Compare the P/N you wrote down to the numbers in the **Current ECM Part Number** column in **Table A**, below.

- If there is a match, this bulletin applies. Continue with the reprogramming procedure.
- If there is not a match, this bulletin does not apply. Close C-III plus and refer to ASIST for further diagnostic information.

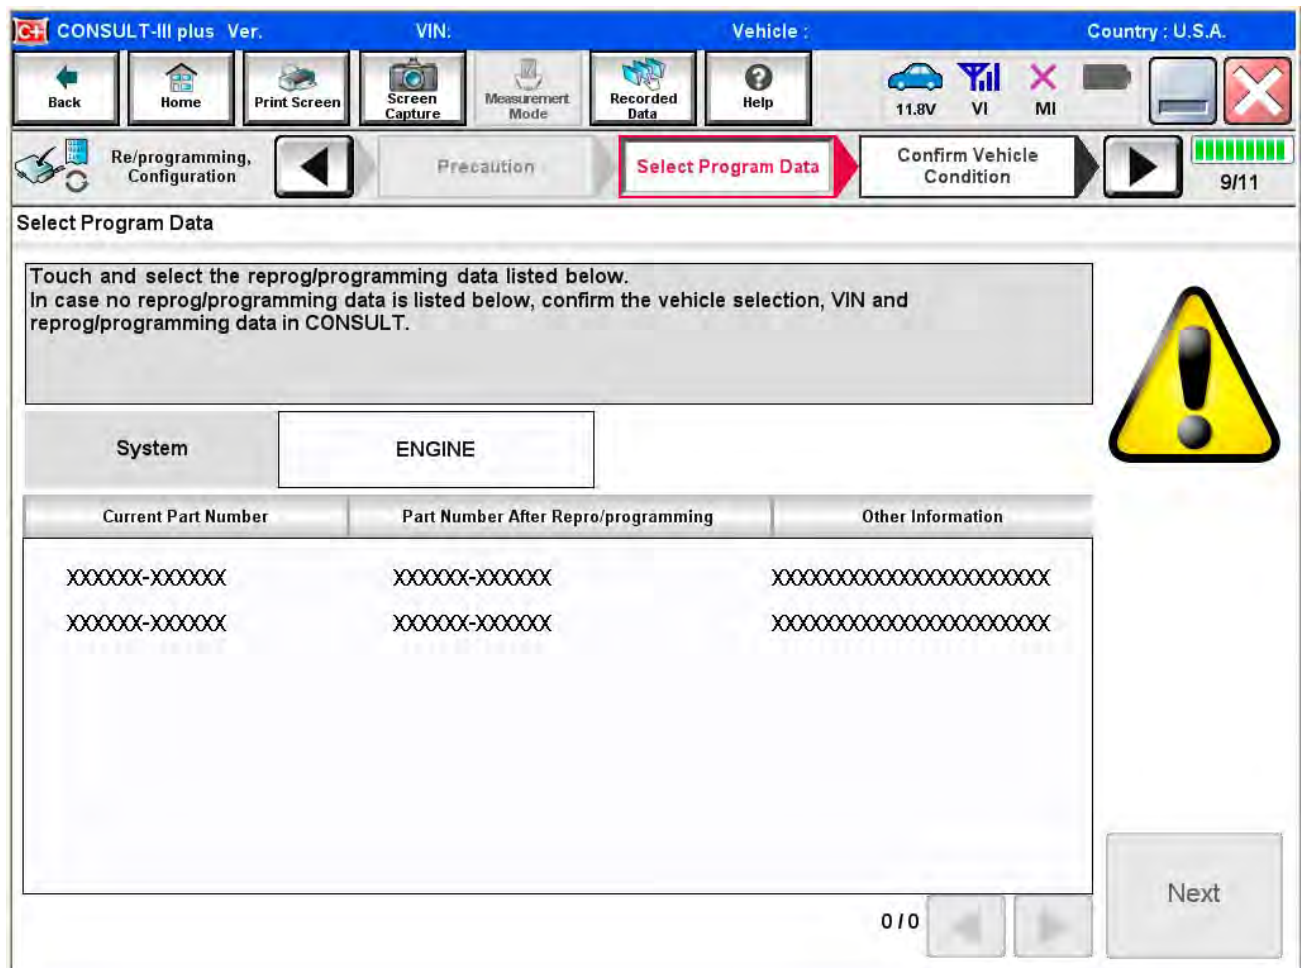
- In some cases, more than one new P/N for reprogramming is available.
 - In this case, the screen in Figure 3 displays.
 - Select and use the reprogramming option that **does not** have the message “Caution! Use ONLY with NTBXX-XXX”.
- If you get this screen and it is blank (no reprogramming listed), it means there is no reprogramming available for this vehicle. Close C-III plus and refer back to ASIST for further diagnosis.

IMPORTANT: If C-III plus locks up or freezes at this point or displays “cannot complete reprogramming, CONSULT PC is set up with User Rights. Reprogramming can be completed with Administrator log in”, the TOUGHBOOK settings need to be changed so that Users have full access rights. See your Dealership’s IT System Administrator for details.

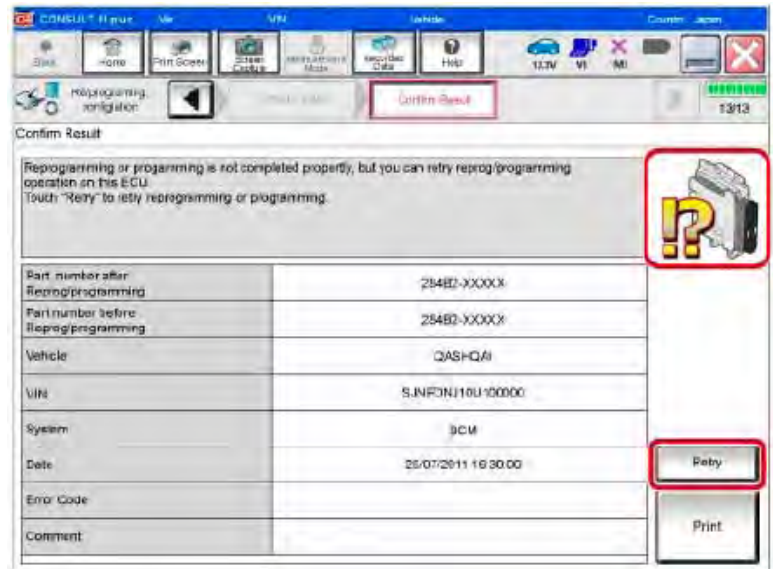
Figure 5

If reprogramming does not complete and the “!?” icon displays as shown in Figure 5:

- Check battery voltage (12.0–15.5 V).
- Ignition is ON, engine OFF.
- External Bluetooth® devices are OFF.
- All electrical loads are OFF.
- **Select retry and follow the on screen instructions.**
- “Retry” may not go through on first attempt and can be selected more than once.

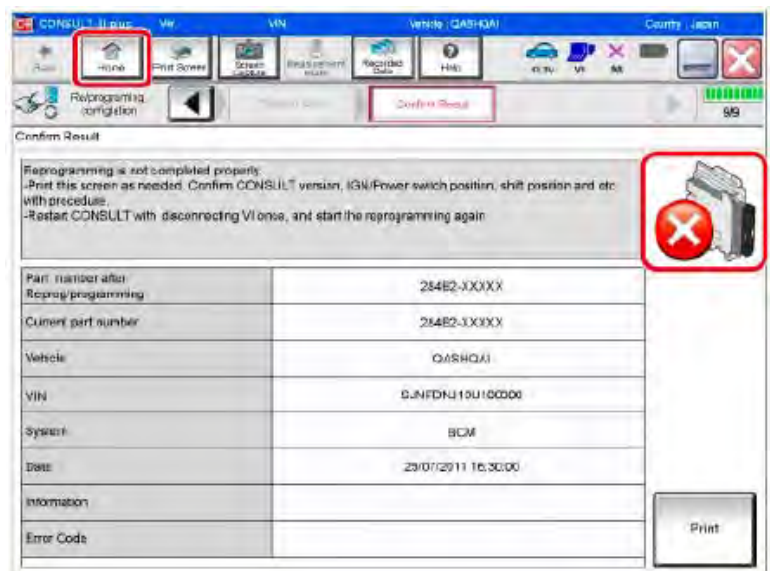
Figure 6

If reprogramming does not complete and the “X” icon displays as shown in Figure 6:

- Check battery voltage (12.0 – 15.5 V).
- CONSULT A/C adapter is plugged in.
- Ignition is ON, engine OFF.
- Transmission is in Park.
- All C-III plus / VI cables are securely connected.
- All C-III plus updates are installed.
- **Select Home, and restart the reprogram procedure from the beginning.**
