Technical Journal

TITLE: Clunking/pulling, Bushing in rear stay broken **REF NO: ISSUING DEPARTMENT: CAR MARKET:** TJ 25336 **Technical Service United States** PARTNER: **ISSUE DATE:** 3 US 7510 Volvo Cars North America MONTH YEAR DAY 11 28 2012 FUNC DESC: FUNC GROUP: Page 1 of 17 6522 **Cross stay**

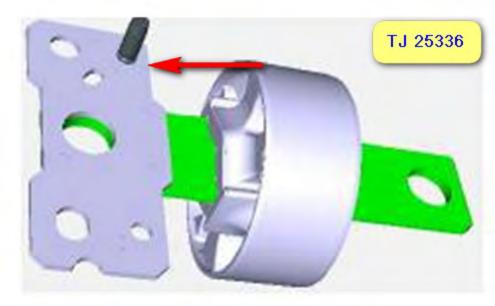
Bushing, left side with standard attachment (see picture #4): PN 31387280 Bushing, left side with large attachment (see picture #5): PN 31387282 Bushing, right side: PN 31387281
