T-SB-0033-12

MIL "ON" DTC P2440/P2442

Some 2012 – 2013 model year Sequoia and Tundra vehicles with the 3UR-FE/FBE (5.7 L) engine may exhibit a MIL "ON" condition with Diagnostic Trouble Code (DTC) P2440/P2442 (*Secondary Air Injection System Switching Valve Stuck Open Bank 1/Bank 2*) under freezing ambient conditions. The Engine Control Module/ECM (SAE term: Powertrain Control Module/PCM) logic has been revised to address this condition. Use the following repair procedure to recalibrate the ECM (PCM).

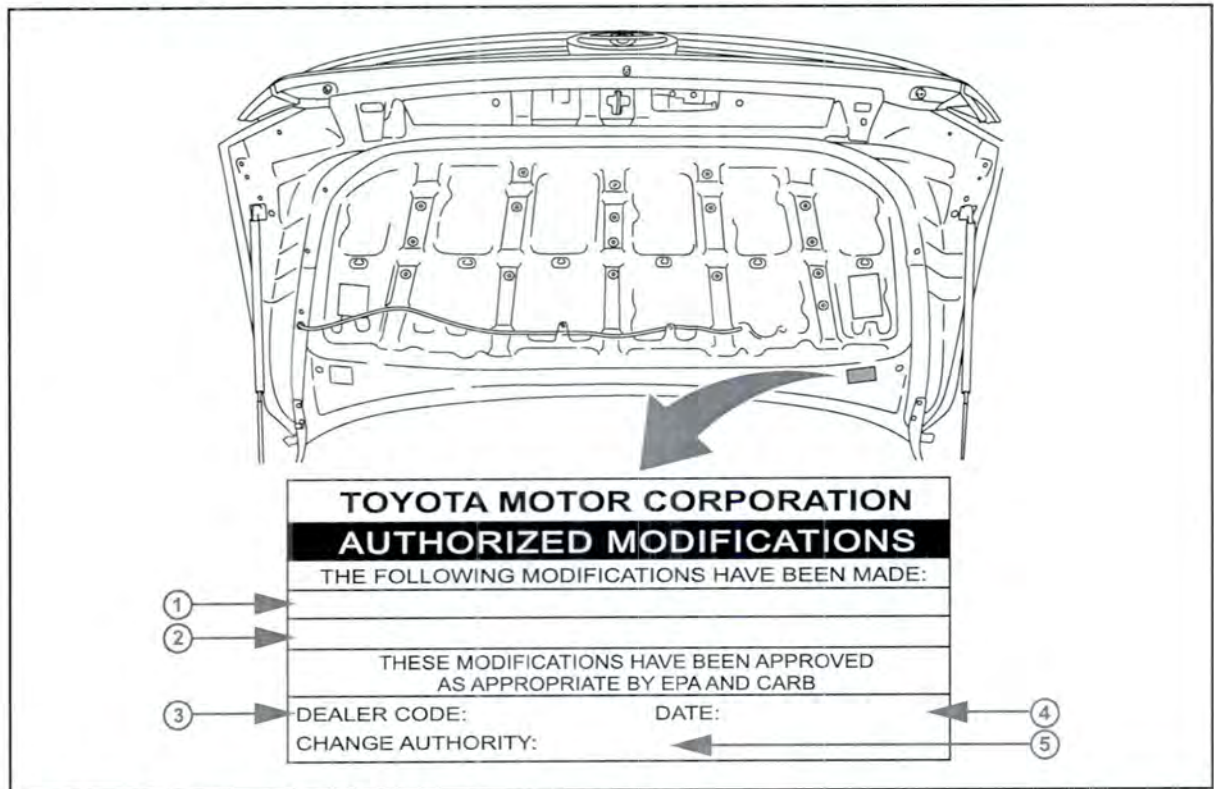
Figure 1. Location of Authorized Modifications Label on 2012 – 2013 Sequoia and Tundra

1. Confirm the condition matches the Introduction.
2. Check for the Authorized Modifications Label affixed to the vehicle in the location shown in Figure 1. Confirm if the ECM (PCM) calibration has been updated. If the calibration ID listed is NOT the latest ECM (PCM) calibration — go to step 3.

4. Install the Authorized Modifications Label.
 - A. Using a permanent marker, enter the following information on the label:
 - ECM part number [Refer to the **Parts Information** section for the **CURRENT PART NUMBER**]
 - Calibration ID(s) [Refer to the **Calibration Identification Chart** for the **NEW CALIBRATION ID**]
 - Dealer Code
 - Repair Date
 - Change Authority [**This SB number**]
 - B. Affix the Authorized Modifications Label to the vehicle at the location shown in Figure 1. The Authorized Modifications Label is available through the MDC, P/N 00451-00001-LBL.
5. Test drive the vehicle to confirm proper vehicle operation.
