S-SB-0023-12

Abnormal Chirp or Squeak Noise from High Pressure Fuel Pump

YEAR(S)	MODEL(S)	ADDITIONAL INFORMATION
2013	FR-S

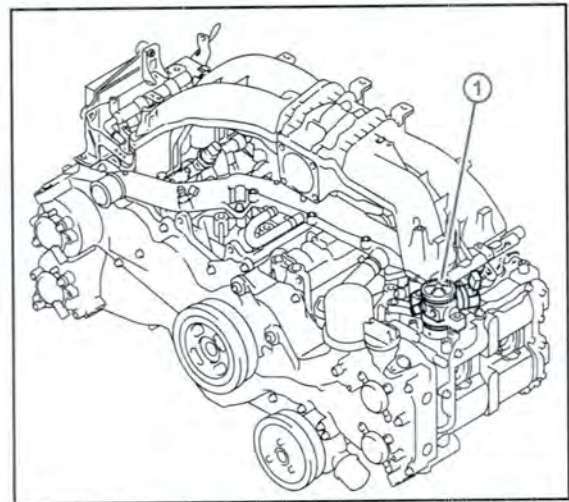
Figure 1.

Some vehicles may exhibit a high pitch chirp or squeak noise from the High Pressure Fuel Pump Assembly when the engine is fully warmed up and idling. Follow the procedure in this bulletin to address this condition.

- A mechanical ticking noise from the High Pressure Fuel Pump Assembly is normal during Direct Injection system operation.
- This bulletin should only be performed if an abnormal high pitch chirp or squeak noise from the High Pressure Fuel Pump is verified.

1 Fuel Pump Assembly (for High Pressure)

4. Replace the High Pressure Fuel Pump Assembly.
