| | GROUP<br>Chassis | MODEL<br>Optima<br>(TF/QF/HEV)<br>2011/13MY |
| | NUMBER<br>039 | DATE<br>September 2012 |
| <b>TECHNICAL SERVICE BULLETIN</b> | | |
| SUBJECT: CAUTION DURING REAR UPPER ARM SERVICE | | |

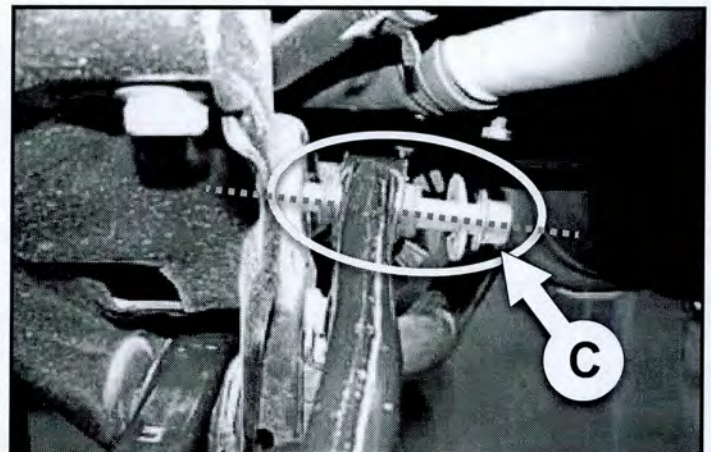
If the bolt is tightened without properly supporting the rear lower arm, the bolt to the subframe may be on a slanted axis (C) as shown in the photo on the right.

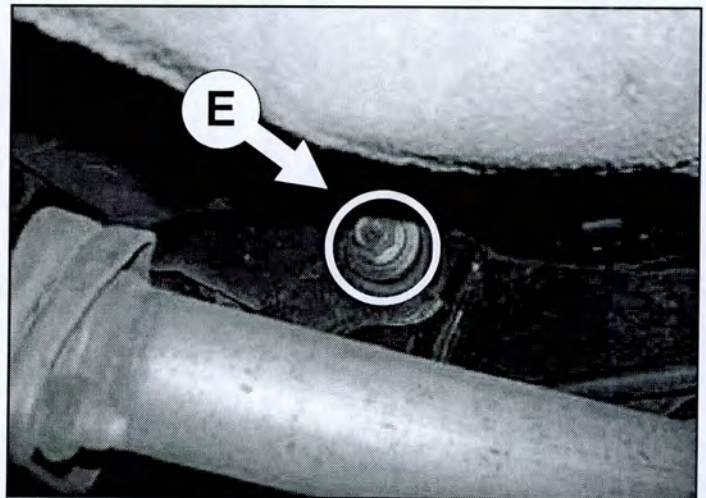
Tightening the bolt without properly aligning the bolt holes of rear upper arm and subframe (horizontally), the bolt (E) securing the rear upper arm to the subframe may become loose, and as a result, rust and noise concerns may occur later on.

4. The rear wheel alignment should be checked after performing this procedure.
