DTCS P0505, P0506 AND/OR ENGINE IDLE RPM FLUCTUATION—HARD START

TSB 12-8-1

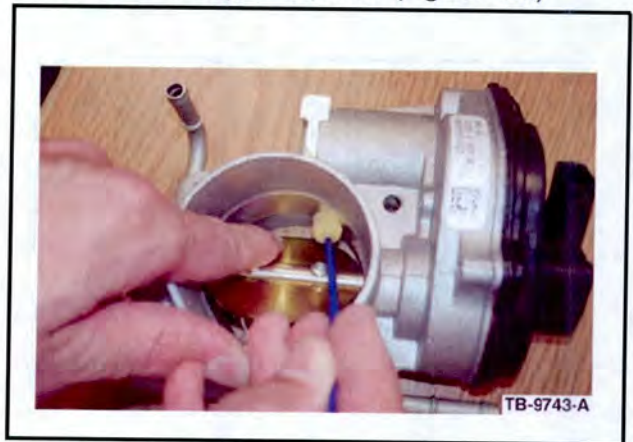
Figure 1 - Article 12-8-1

Various vehicles may exhibit Diagnostic Trouble Codes (DTC) P0505, P0506 and/or engine idle RPM fluctuation and hard starts. Some vehicles may also exhibit DTCs P2111 and P2112 after a keep alive memory (KAM) clear, battery disconnect or dead battery. On vehicles with over 10,000 miles, the issue may be caused by sludge buildup in the throttle body leading to less than desired airflow.

3. Using Integrated Diagnostic System (IDS) scan tool or equivalent, monitor the PID values of IACTRIM and IACKAM2 while the engine is running. The sum of IACTRIM and IACKAM2 is the total IAC. Is the total IAC greater than 0.5 lb/min?
 - a. Yes - proceed to Step 4.
 - b. No - this article does not apply. Refer to Powertrain Control/Emissions Diagnosis (PC/ED) manual for normal diagnostics.
4. Remove the throttle body. Refer to Workshop Manual (WSM), Section 303-04.
5. Using Motorcraft® Choke and Linkage Cleaner or equivalent, spray the throttle body plate and bore. Using a small, soft, solvent-resistant brush, clean the edges of the throttle plate and the mating surface of the throttle bore to remove all engine deposits. (Figures 1-2)
