**SB-10048181-4528**  
Service Campaign Bulletin

Campaign No. 2012080001, September 2012

SUBJECT: **Model 204 with Engine M156**  
**Model Year 2012**  
**Replace Ignition Coils**

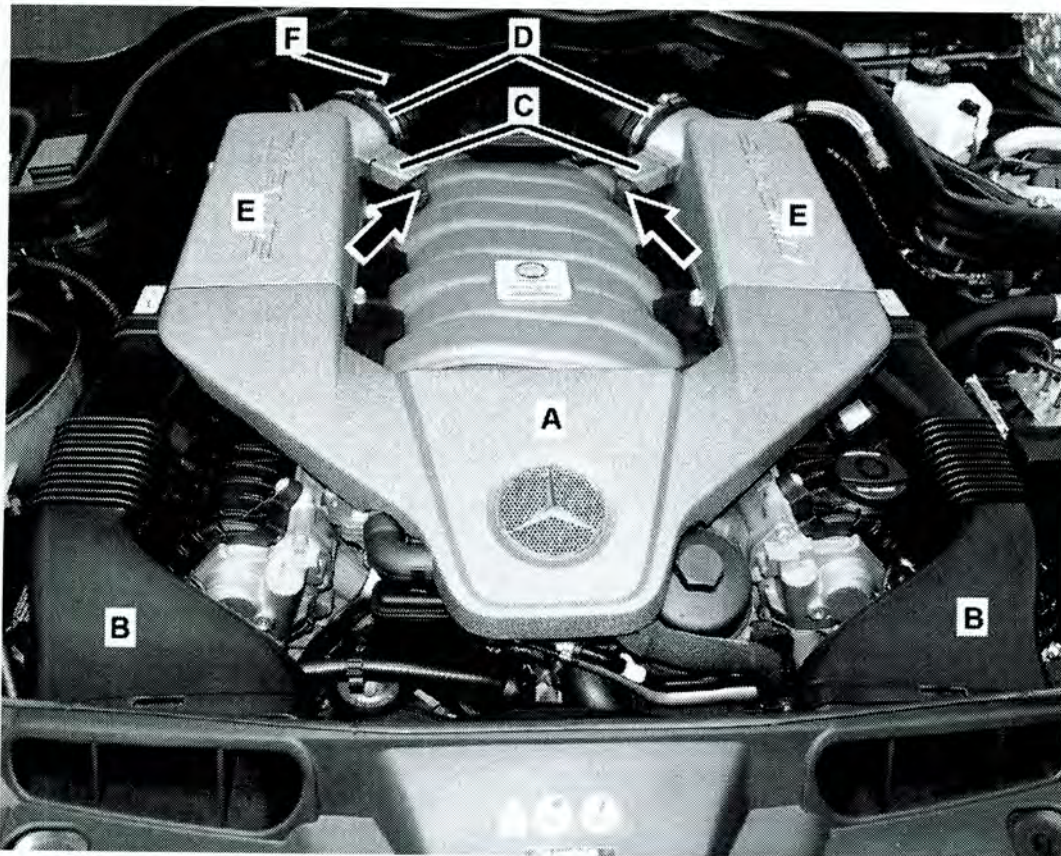
Figure 1

This Service Campaign has been initiated because Daimler AG (DAG), the manufacturer of Mercedes-Benz vehicles, has determined that uncontrolled charging and discharging of the ignition coils may result in a high primary current and engine misfire. Dealers will replace the eight ignition coils at the next workshop visit

1. Remove front engine cover (A, Figure 1)

2. Remove air intake ducts (B, Figure 1).
3. Remove covers (C, Figure 1) over mass airflow meter harness connectors (arrows).
4. Release, then disconnect mass airflow meter harness connectors (arrows, Figure 1).
5. Loosen hose clamps (D, Figure 1) then remove air filter housings (E).

6. Replace 8 ignition coils, refer to WIS: AR15.12-P-2003CMG.

**Torque screws securing ignition coils to cylinder head cover to: 6 Nm +/- 0.5 Nm or damage to cylinder head cover may occur.** (Disregard torque specification in WIS instructions, this specification applies to aluminum valve covers only.)
