Service Campaign Bulletin

Campaign No. 2012070002, November 2012

SUBJECT: **Models 164, 171, 203, 204, 207, 209, 211, 212, 216, 219, 221, 230, 251, 463**
Engines 272 and 273
Model Years 2005 - 2011
Retrofit Adapter Wiring Harness on Camshaft Adjustment Solenoids

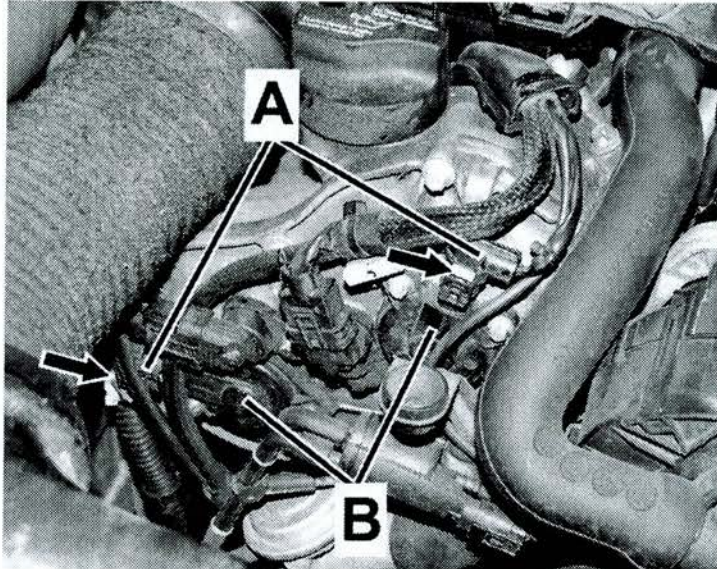
Figure 2

Note: Shown on engine 272

1. Remove top engine cover to get access to camshaft adjustment solenoids as required.
2. Disconnect camshaft adjustment solenoids from engine harness connectors (A, Figures 1 and 2):
 - Carefully unlock engine harness connectors (A) by squeezing and **partially** pulling out locking tabs (arrows) using pocket screw driver.
 - Disconnect camshaft adjustment solenoid connectors (A) from camshaft solenoids (B).
