Cam Tube Support Brackets on Wide Base Wheel Equipment CHU, CXU, GU

PI0799, Camshaft Tube Support Brackets

(November 2012)

Cam Tube Support Brackets on Wide Base Wheel Equipment Replacement Procedure

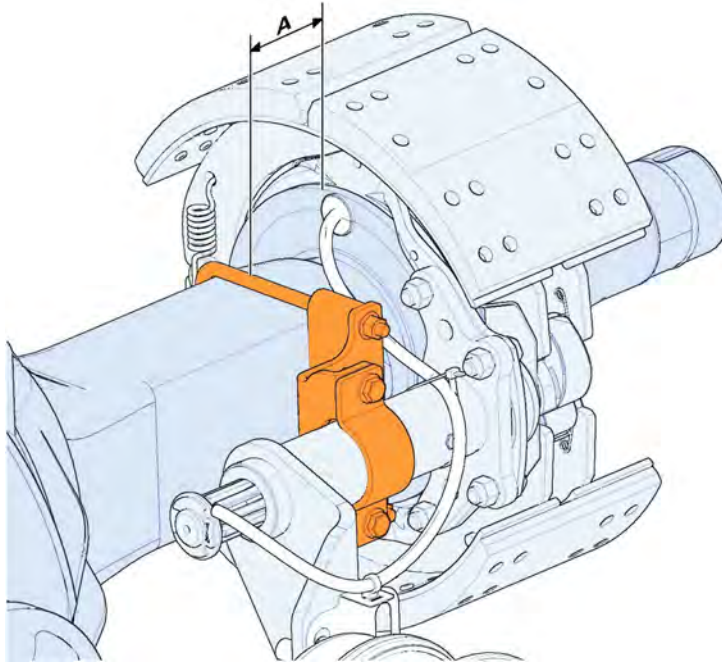
W5076042

A = 80 mm (3 in.)

Note: Measure the distance of 80 mm (3.1 in) from the inner axle flange to the center of the U-bolt. Set this distance before final tightening.

- 1 Secure the vehicle for service by parking it on a flat level surface, applying the parking brake, chocking the rear wheels, and placing the transmission in neutral or park.
- 2 Disconnect all cables from the negative (ground) battery terminals to prevent personal injury from electrical shock and prevent damage to electrical components.
- 3 Position parts Kit 85121423 onto rear axle end and loosely install around the axle housing and s- cam tube.
Note: On axles having an ABS sensor, cut the cable ties and temporarily move the sensor wire off of the s-cam tube.
- 4 Tighten the U-bolt assembly evenly and torque to 60 Nm (44 ft-lb).

- 5 Tighten the s-cam tube bracket clamp and torque 60 Nm (44 ft-lb).

Note: Keep the space even as possible between the ends of the clamp before final tightening.
