**SB-10048439-6161**

## Technical Information Bulletin

**E063**

PACCAR MX Air Compressor-Fuel Line Clip Campaign

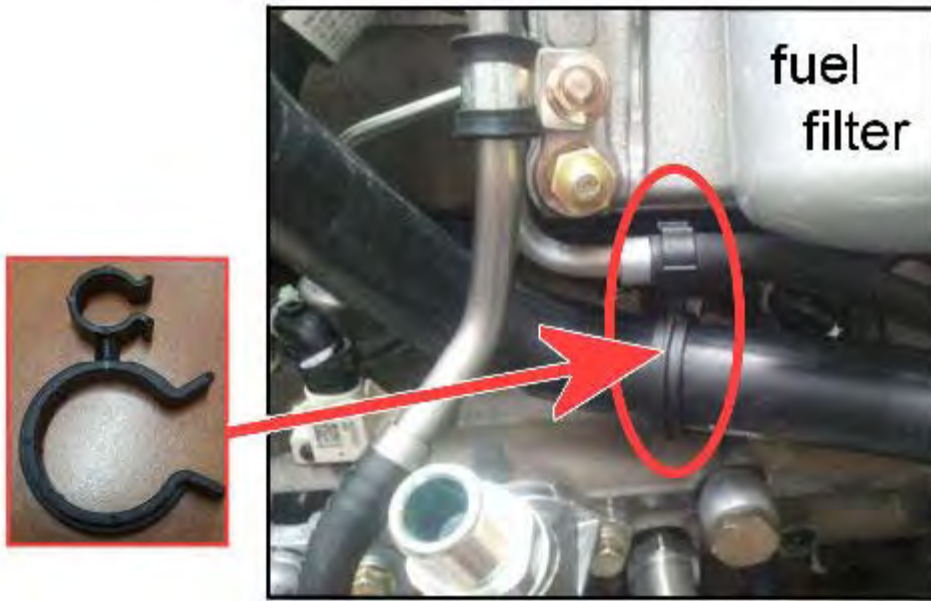
Chassis listed were manufactured without an air compressor suction hose support clip and campaign E063 describes the repair to correct this shortage.

An updated hose routing resulted in a longer distance between compressor suction hose suspension points and the additional clip is intended to prevent rubbing and possible long term flex and wear of that hose. Current production engines include the additional clip but chassis listed were manufactured prior to implementation of this clip.

Join the two support clip pieces together and install as depicted, at the rubber-to-metal fuel line joint and near the turn of the flexible compressor suction hose.
