# Authorized Field Change

AFC 12942

**Subject:** Fan Clutch Harness Routing Repair

Model: ProStar® and TranStar®

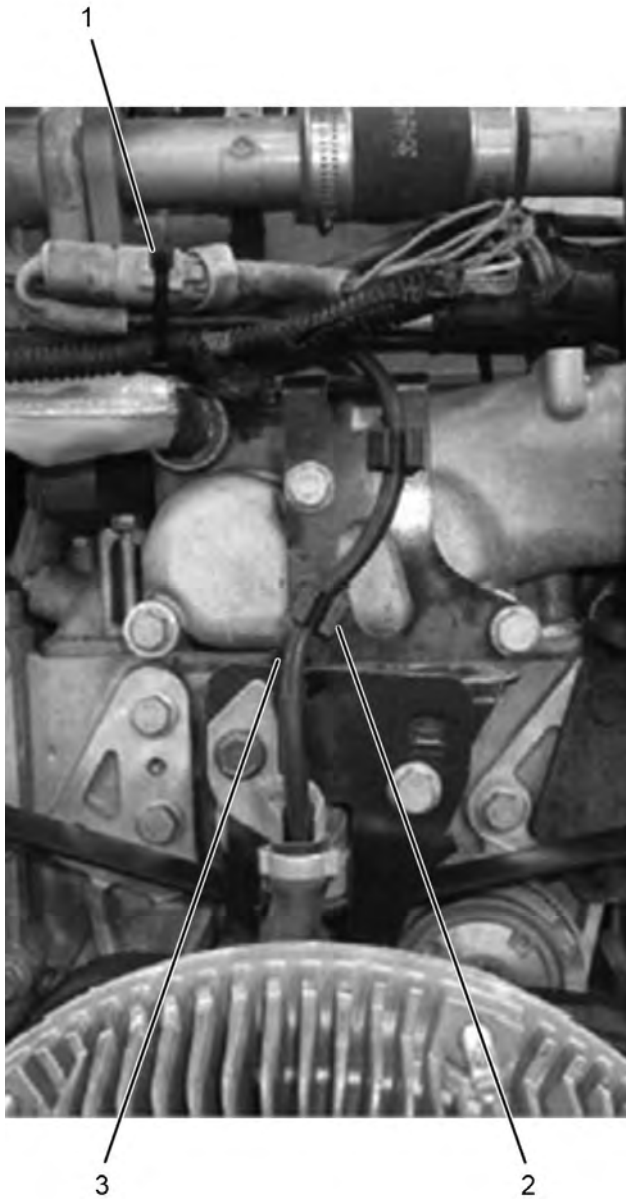
**Figure 2. Fan Clutch Harness Incorrectly Installed.**

The fan clutch harness can rub on the fan wiring harness bracket and cause intermittent fault codes. Some of the symptoms can include: Low Power, Erratic Fan Engagement, No Fan Engagement, or a VREF 4 DTC code. This repair will require rerouting the harness, inspecting the harness for abrasion, and repairing the harness, if required.

1. Tie strap
2. Lower fan shroud push mount cable tie
3. Abrasion point

6. If harness is routed incorrectly (refer to Figure 2), follow remaining steps of this procedure.

7. Remove tie strap (Figure 2, Item 1) securing fan clutch harness connector to engine harness. Discard tie strap.
8. Gently pull fan clutch harness toward fan clutch.

9. Remove lower fir tree push mount cable tie (Figure 2, Item 2) from fan clutch harness. Discard fir tree push mount cable tie.
10. Inspect fan clutch harness for damage:

- a. If no damage is observed, make sure there is clearance between fan clutch harness and bracket.
    1. Gently pull fan clutch harness upward to gain clearance from bracket. Install new tie strap (Figure 2, Item 1) securing fan clutch harness to engine harness where previously removed.

- b. If damage is observed, repair harness as follows:
    1. If only outer protective sheath or outer sheath and part of insulation on wire harness is damaged, install heat shrink over damaged area.

2. If copper is showing on any wires, fan clutch harness must be repaired following IK0800269.
      - A. When fan clutch harness repair is complete, heat shrink must be installed over harness where sheathing was located.

3. Insert fan clutch harness into top fir tree push mount cable tie.
    4. Gently pull fan clutch harness upward to eliminate slack in harness.
    5. Verify that there is clearance between fan clutch harness and fan clutch harness bracket (Figure 2, Item 3).

6. Install new tie strap (Figure 2, Item 1) securing fan clutch harness to engine harness where previously removed.
11. Close hood.
12. Remove wheel chocks.
