SB-10049679-2750

SI B12 18 12
Engine Electrical Systems

SUBJECT**N63: Proper Engine Harness Installation and Ground Connections****MODEL**

All with N63

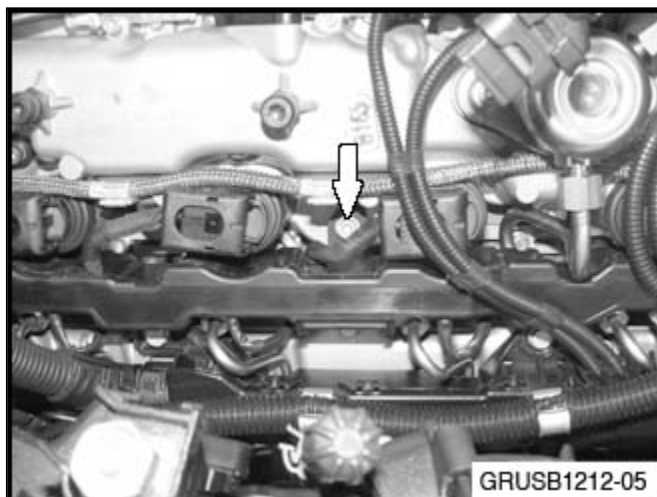
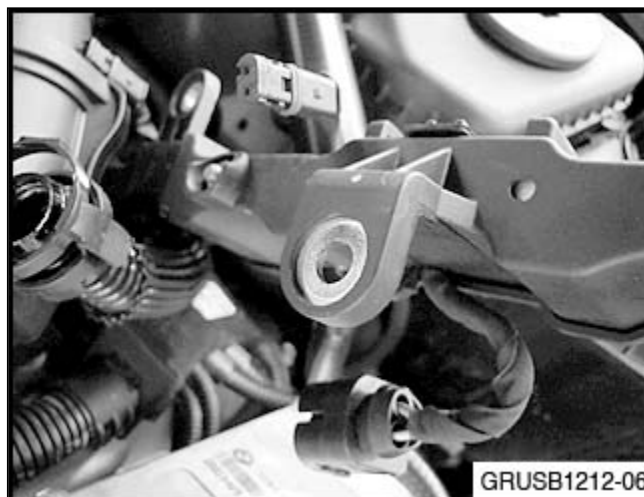
A BSD component may become damaged immediately upon engine operation if the ground circuit, integrated into the metal bushing of the ignition coil harness duct on either cylinder bank, is not properly secured to the engine cover with the correct bolt and to the specified torque.

This ground point location is shown in the pictures below.

It is absolutely essential that during any engine repairs which require loosening or removing of the harness, special attention must be paid during reassembly to ensure these ignition coil harness bolts be the correct part and tightened to the specified torque before attempting to start the engine.
