This Service Information bulletin supersedes SI B61 04 05 **dated July 2005**.

Power Mirrors and/or Windows are Inoperative

NEW E90

NEW Equipped with option 522 (Xenon lights)

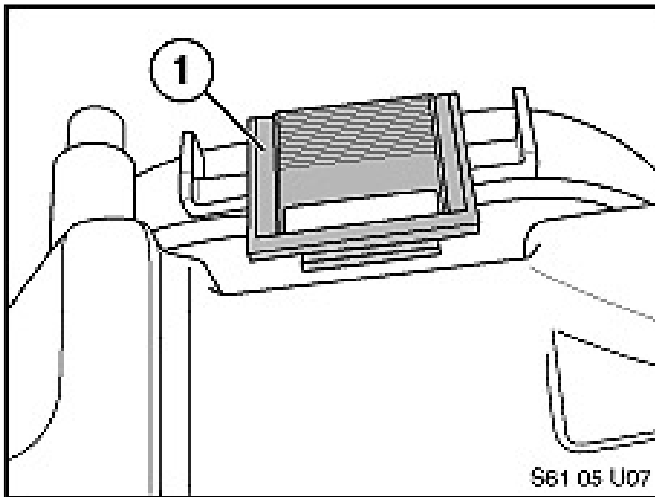
Left and/or right headlight housing cover is not properly fitted allowing water ingress into the Stepper Motor Controller (SMC) connector.

2. **NEW** Inspect the connector at each headlight (X13420 – Left and X13421 – Right) assembly for corrosion and replace as necessary.

3. **NEW** Make sure the headlight access covers (1) are installed correctly.
4. **NEW** Clear the faults and test the headlights for proper function.
