**SB-10049779-5535**

**Title:** Water leaks through Cab Cowl pass-through connections

**Applies To:** TerraStar, DuraStar, WorkStar, TranStar, ProStar, LoneStar

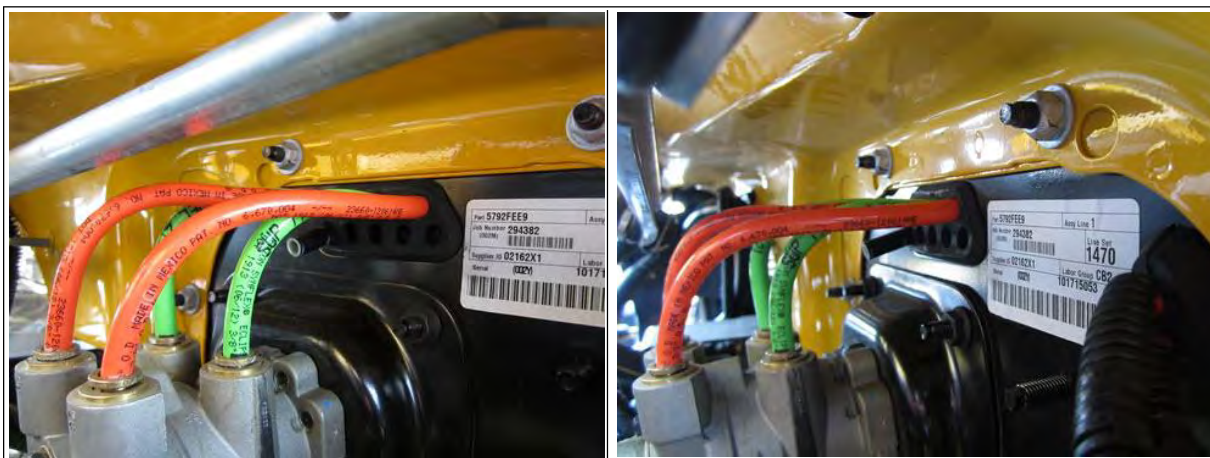
\*Exterior view of one of the Grommets in question\*

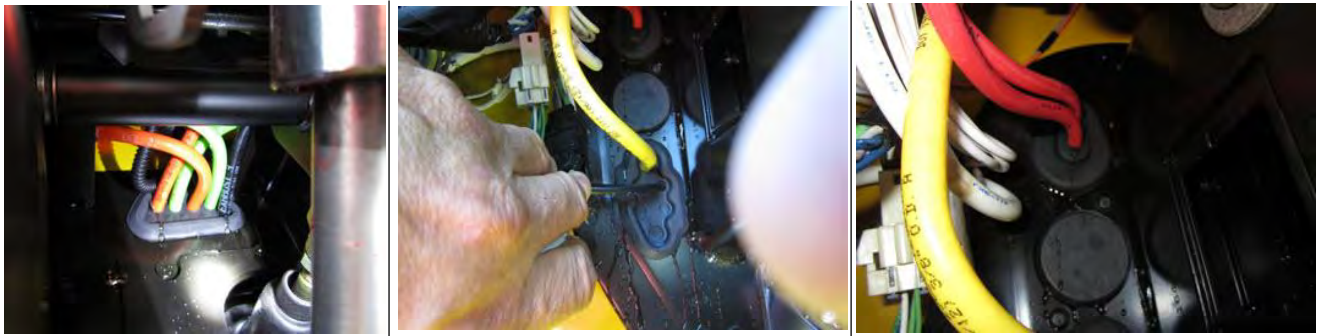
\*Interior view of one of the Grommets in question\*

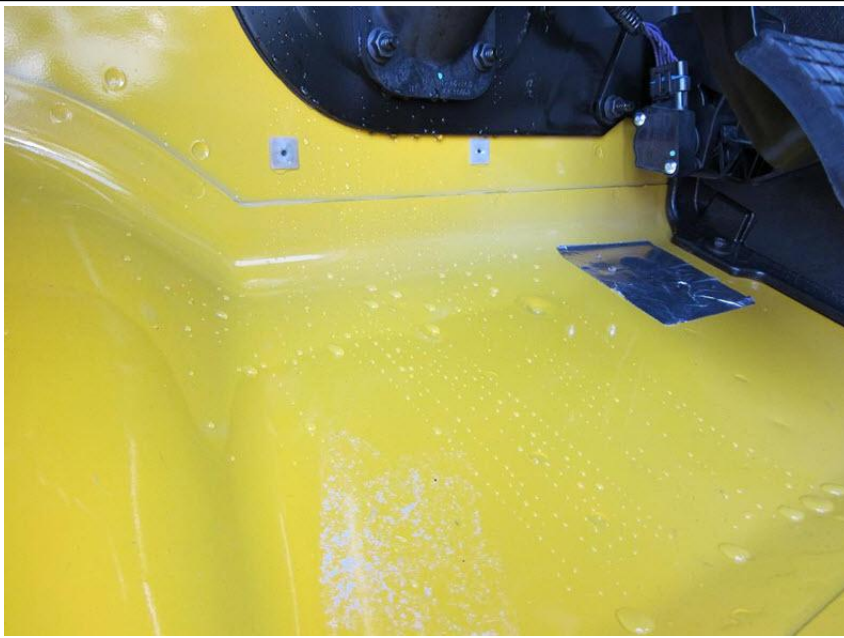
\*Evidence of the leaks on the floor of a new truck\*

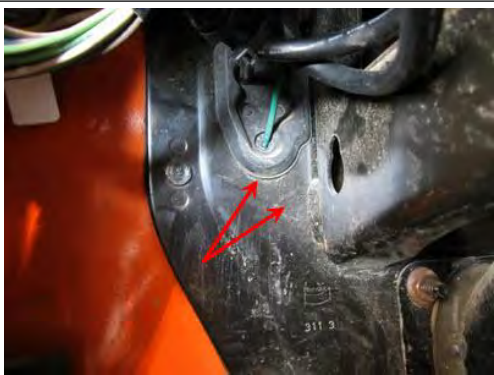
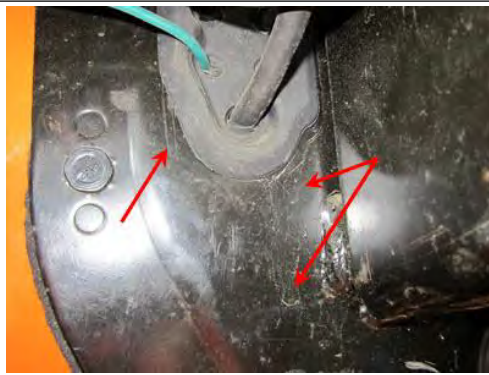
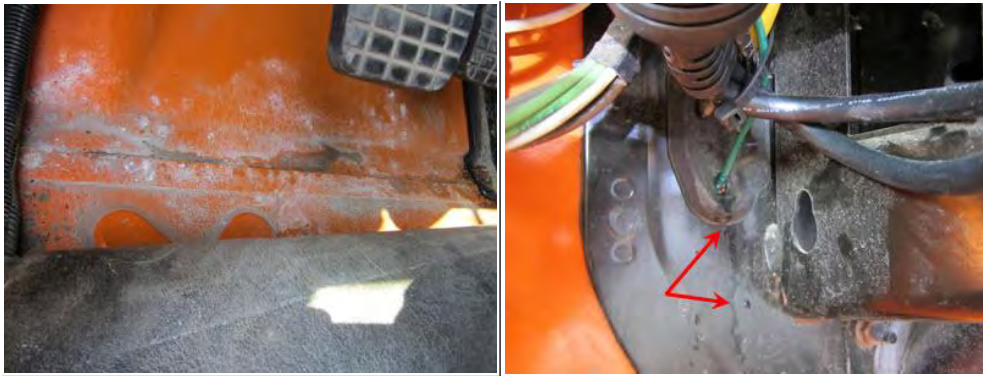
\*Evidence of the leaks on older trucks\*
