SERVICE BULLETIN

Classification: EL11-015b	Reference: NTB11-041b	Date: December 11, 2012
------------------------------	--------------------------	----------------------------

2011 – 2012 LEAF; NO TELEMATICS CONNECTION

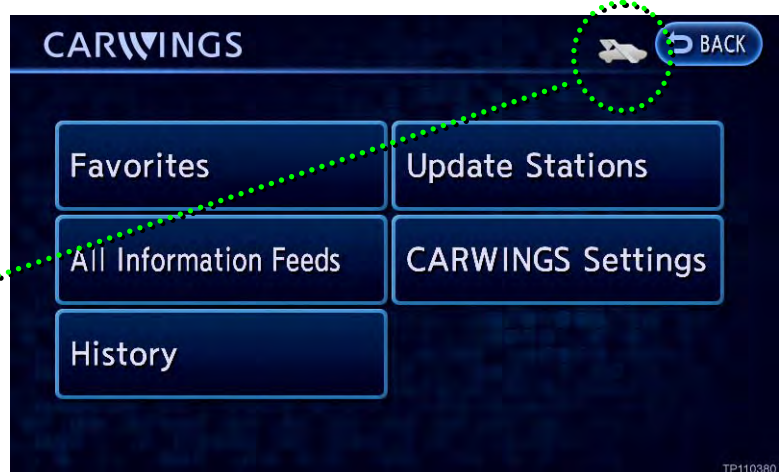
Figure 1

- The vehicle had a proper telematics signal/connection and operation previously, but now the telematics symbol indicates no signal/connection in any location or there is no symbol at all.

No telematics connection =

- DTCs U1A03 and/or U1A05 are present.

- Perform Section 1 of the SERVICE PROCEDURE (“**Software Version Check of TCU**”) to determine if this bulletin applies.

If this bulletin does apply, perform software updates for the Telematics Control Unit (TCU) as instructed in the SERVICE PROCEDURE.

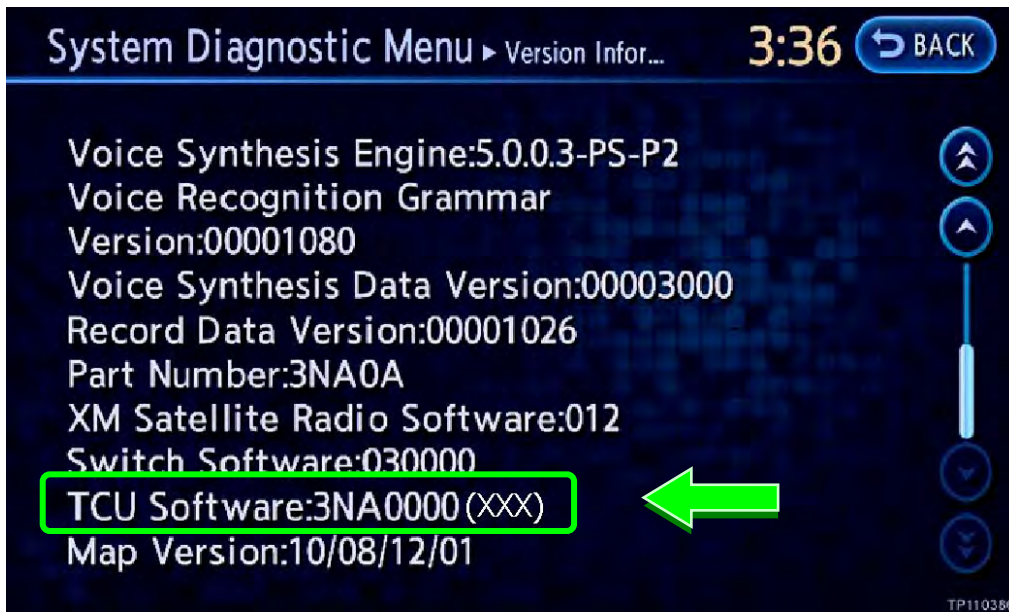
Figure 10

12. Check the **TCU Software** version. See Figure 10.

If the TCU Software version is 3NA00006**28** or higher:

If the TCU Software version is not 3NA00006**28** or higher:

2. Clear any DTCs from TCU with CIII plus.
 - If hard codes are present:
 - a. Turn ignition off.
 - b. Wait for at least 5 minutes (additional DTCs may be set if the battery is disconnected before 5 minutes. Refer to TSB NTB11-034a).
 - c. Disconnect and then reconnect 12V battery negative terminal.
 - d. Erase any remaining past codes with CIII plus.
3. Perform **Section 2 - Software Update: TCU** on the next page.

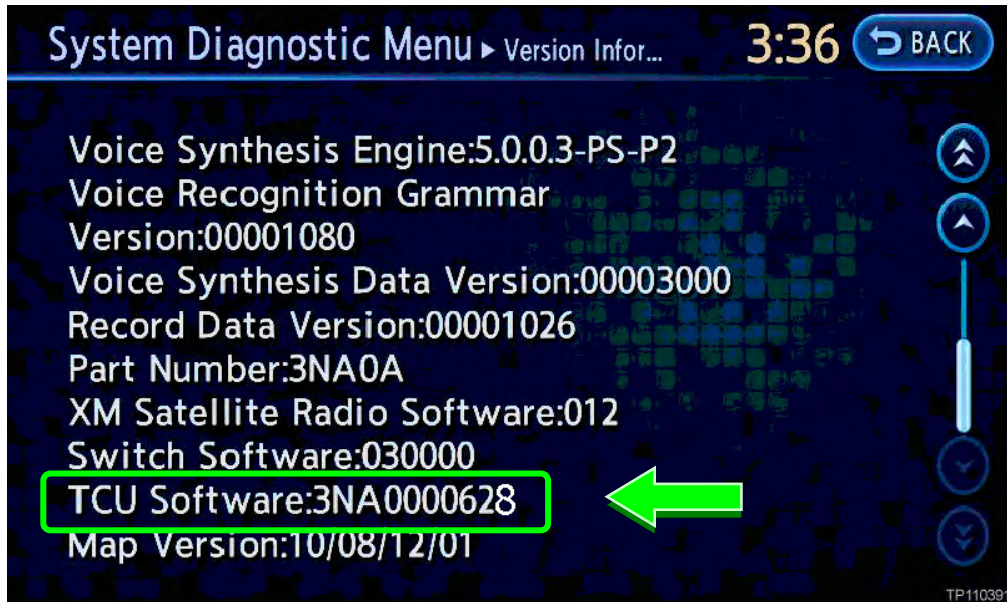
Figure 51

13. Confirm the **TCU Software** version is 3NA0000628 or higher. See Figure 51.

NOTE: If the TCU software version is not 3NA0000628 or higher, perform **Section 3 - Software Update: TCU** again.

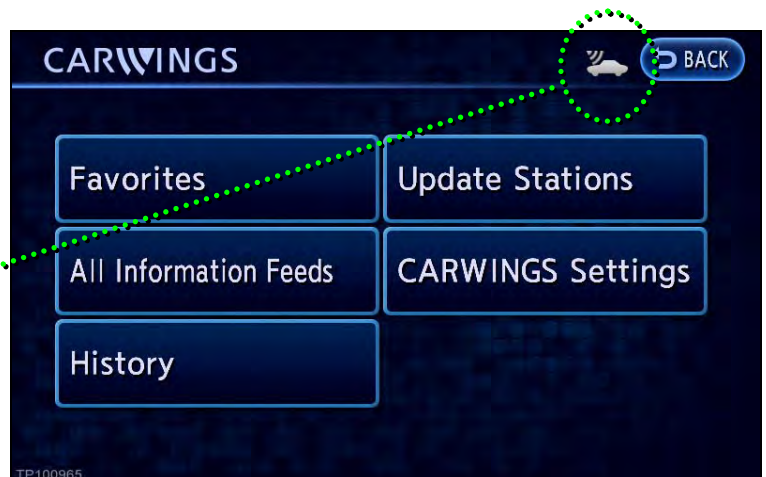
Figure 54

3. Confirm the telematics symbol indicates the vehicle telematics features are connected.

Telematics connected =
