**SUBARU**

SERVICE BULLETIN

NUMBER: 11-124-12R

SUBJECT: Difficulty Starting, Rough Idle, Cam Position or Misfire DTCs P0301, P0302, P0303 or P0304 DTCs P0340, P0341, P0345 or P0346

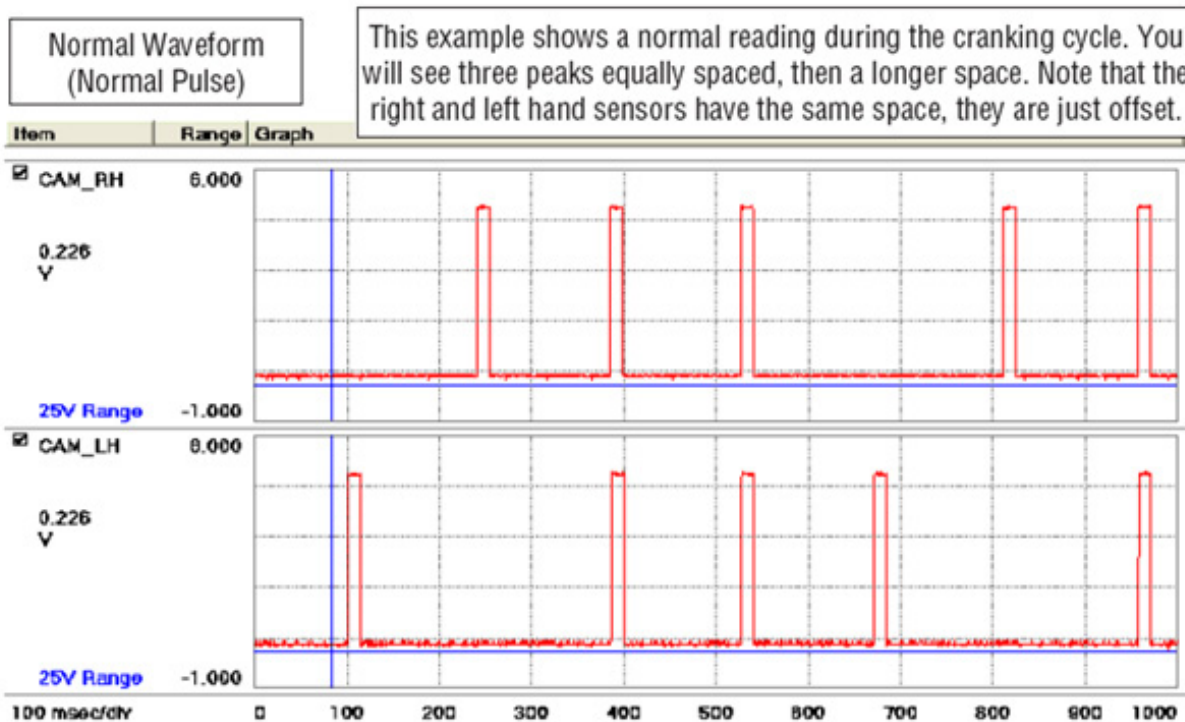
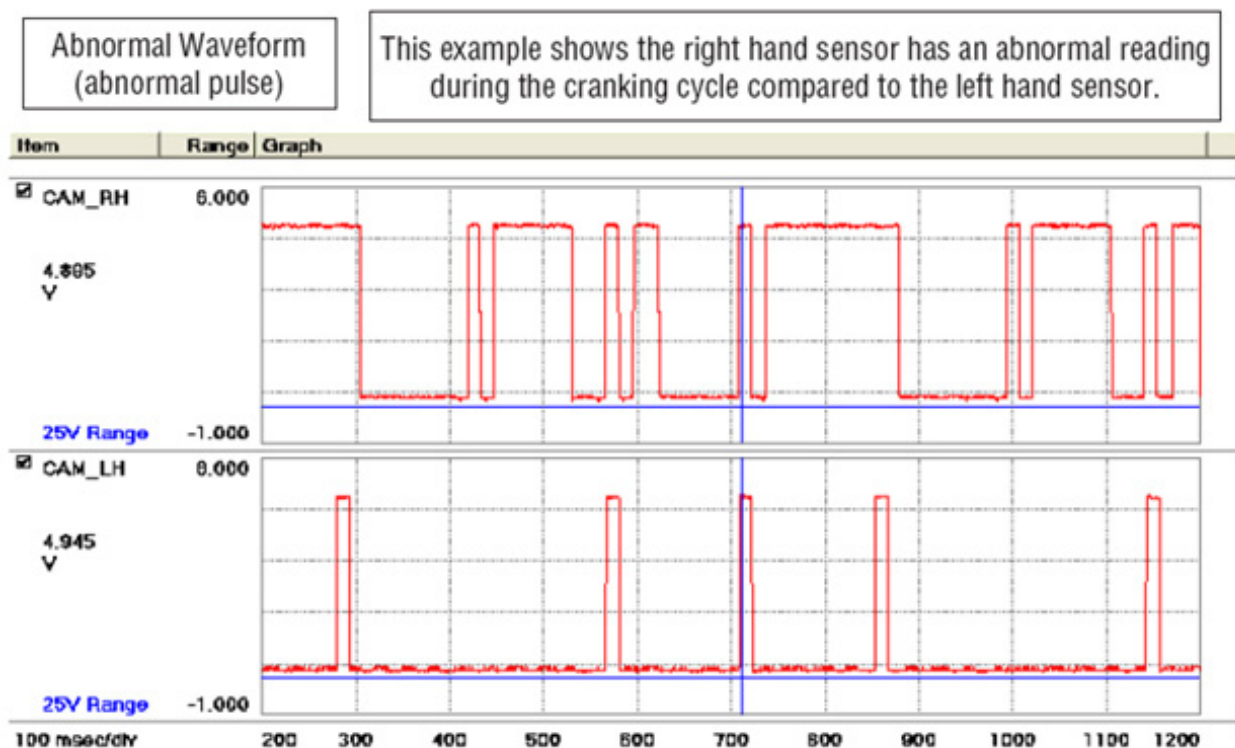
The following illustrations show a normal oscilloscope pattern followed by an abnormal pattern.

If an abnormal pattern is verified similar to those shown in the illustration above, measure the clearance between the end of the camshaft position sensor and the sensor plate using the following procedure. If the oscilloscope pattern is normal, refer to the applicable Service Manual for additional troubleshooting and diagnostic procedures.

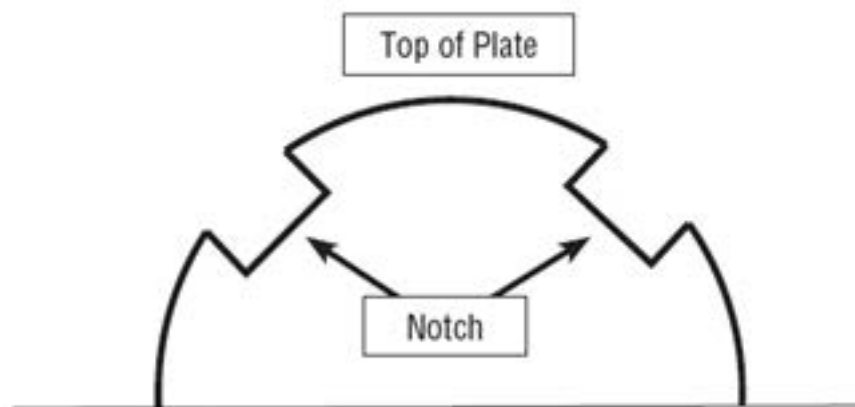
NOTE: When measuring “A”, make sure you are measuring to the outside diameter or “top” of the sensor plate and not to the bottom of a notch as shown below. Be sure to record all measurements.
