# Technical Service Bulletin

## 00 - Engine shuts off and/or EPB activates when driver door is opened

46 12 27 2031850/1 November 20, 2012.

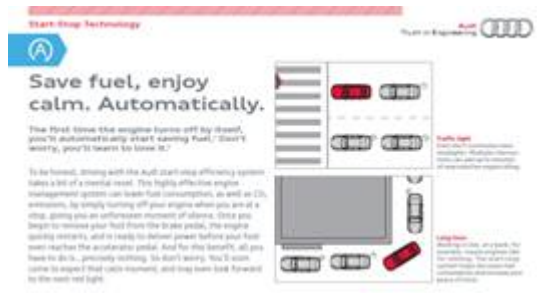
Figure 1. Old Start-Stop glovebox insert.

4. If available, replace the old Start-Stop glovebox insert (Figure 1), with the new glovebox insert BR-12-631-US (Figure 2). Additional inserts may be ordered from the Brand Store.

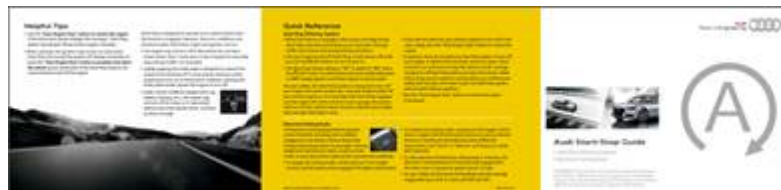
Figure 2. New Start-Stop glovebox insert.
