Technical Service Bulletin

87 Moisture in driver or front passenger footwell

87 12 34 2024644/5 November 9, 2012. Supersedes Technical Service Bulletin Group 87 number 12-31 dated September 5, 2012 for reasons listed below.

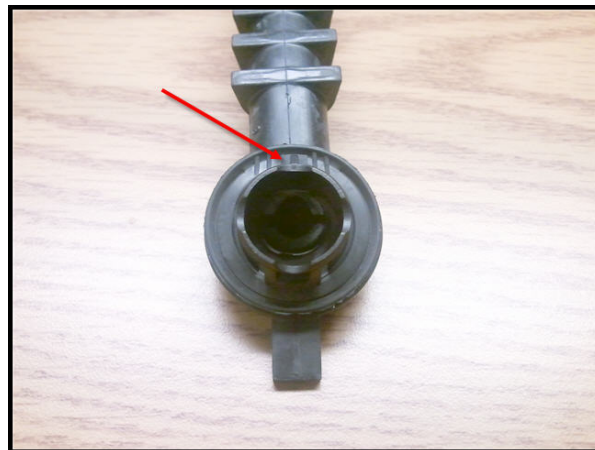
2. Inspect both drain hoses to identify if they are incorrectly assembled. An incorrectly assembled condensation drain hose is one where the locating tab is pointing up as seen in Figure 1. The correct orientation for this locating tab should be pointing down.

Figure 1. Incorrectly assembled drain hose, with locating tab pointing up.

3. Should the snap ring have been incorrectly installed to the body of the vehicle, do not repair the condensation drain hose assembly. Replace the hose using the repair procedure in *ElsaWeb >> Heating, Ventilation and Air Conditioning >> 87 Air Conditioning >> Removal and Installation >> Condensation Water Drain Hose*. Improper installation at the factory may have damaged the snap feature (opposite the locating tab), thus creating a poor seal to the body.

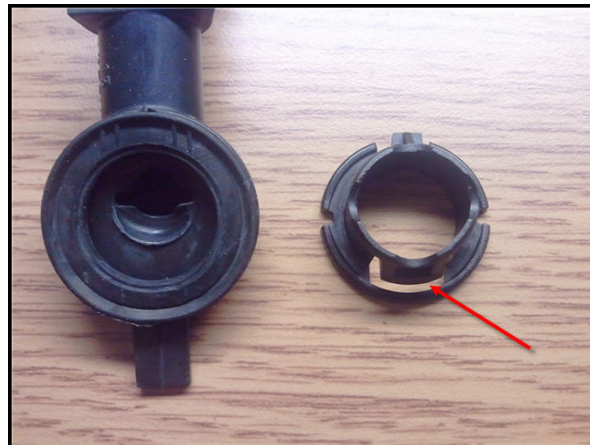
When the snap ring is installed upside down, it allows condensation to leak out through a hole at the bottom of the snap ring (Figure 2). The water can then migrate into either of the front footwell carpeted areas.

Figure 2. Hole in snap ring.

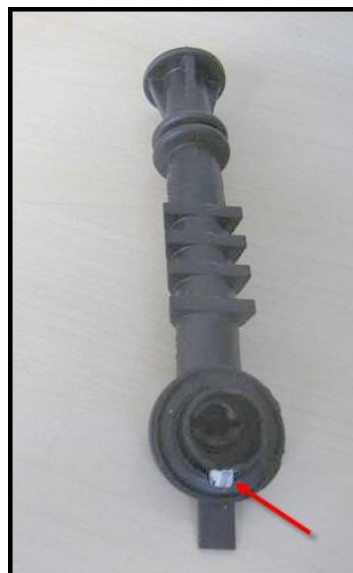
Service parts have been checked, but it is still possible to receive unchecked parts. Corrected parts will be marked in white on the locating tab. This tab must be pointing down (Figure 3).

Figure 3. White mark on locating tab.

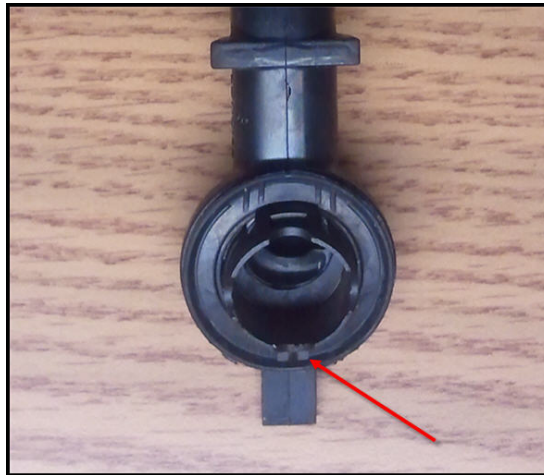
Figure 4. Snap ring installed in the correct position.

4. If the locating tab on the new part is in the wrong position (pointing up), then use a small set of needle nose pliers to gently pull the snap ring out of the rubber hose and align it in the correct position (pointing down). Dipping the end of the hose in soapy water may make the process easier.
5. Reinstall the snap ring in the correct position indicated by Figure 4.
