Technical Service Bulletin

94 Headlight Warning On in Cluster (Xenon Plus With or Without Adaptive Light)

94 12 99 2029194/2 November 30, 2012. Supersedes Technical Service Bulletin Group 94 number 12-74 dated April 23, 2012 for reasons listed below.

Model(s)	Year	VIN Range	Vehicle-Specific Equipment
Q7	2010-2014	All	Premium Plus and Prestige

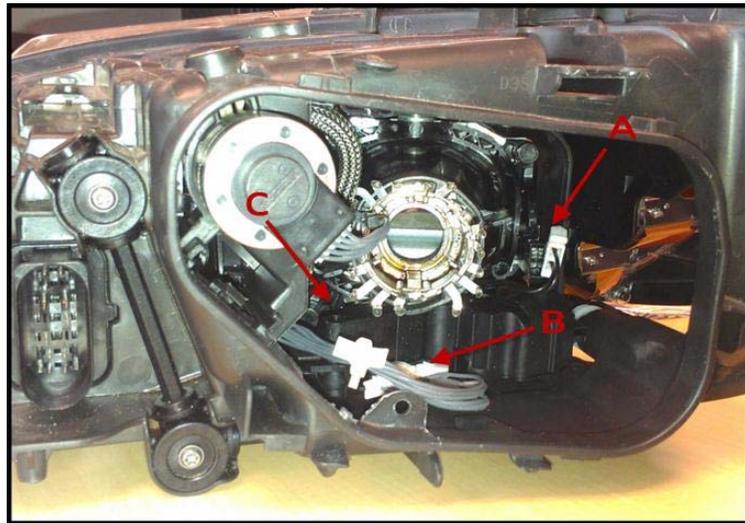
One or more of the connectors inside the headlamp housing are disconnected fully or partially from the factory.

Figure 1. Back of Tri-Xenon Headlight showing three connectors, “ A ” , “ B ” , “ C ” . Bi-Xenon Headlight will only have a single “ A ” connector.

3. Physically check all the connectors inside the headlamp housing for proper seating and visually inspect the locks to ensure they are fully engaged.

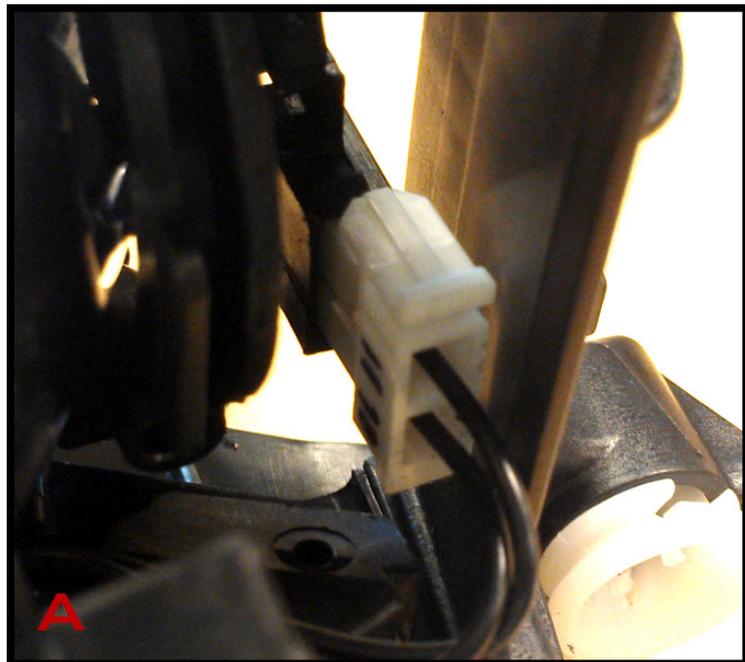
Connector “ A ” (Figure 2, A) can be seated but not fully engaged. When pushing on this connector the projector will swivel, thus you will need to hold the projector housing when applying pressure to the connector.

Figure 2. Connector “ A ” shown not fully seated.

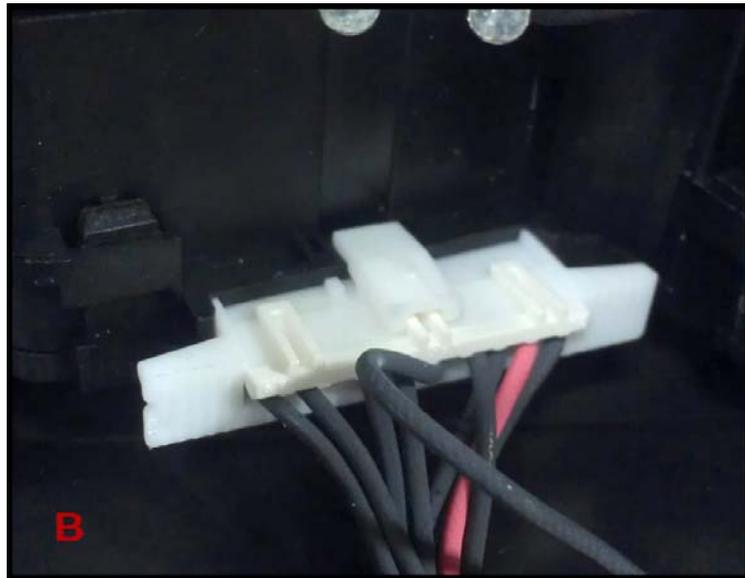
Connector “ B” (Figure 3, B) can be fully locked into place but it can be rotated 5-10 degrees off center. Thus, please check to ensure the harness connector is seated parallel to the connector housing on the headlamp.

Figure 3. Connector “ B” shown off center.

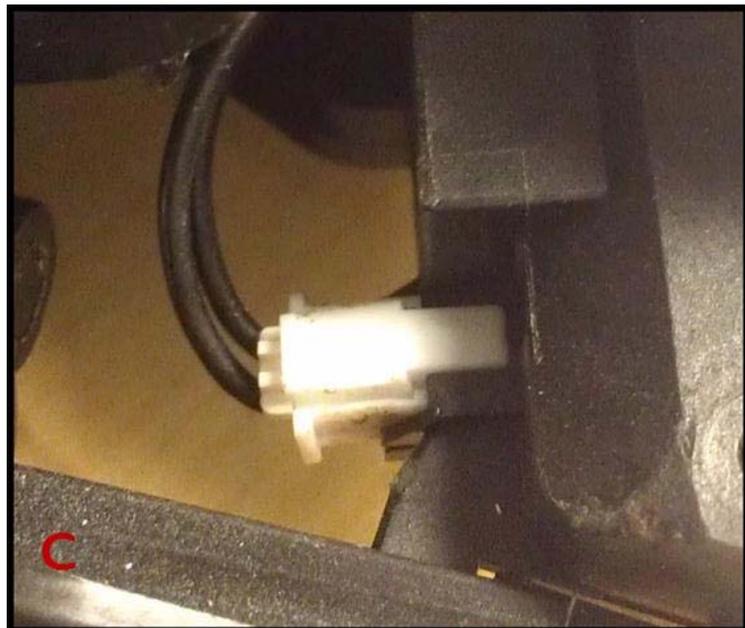
Connector “ C” (Figure 4, C) is located behind the motor mechanism, which rests below the projector lens. This is a very small two-pin connector. Take care when wiggling this connector because if it becomes fully disconnected, it is very difficult and almost impossible to reconnect without using special tools. Place your finger, or a set of small bent pliers, on this connector and pull towards yourself to fully seat the connector.

Figure 4. Connector “ C” shown in the locked position.
