Bulletin No.: PI0093A

Service Bulletin

Subject: Intermittent Click/Clunk Type Noise from Steering Column Area During Turns

Models: 2009-2012 Chevrolet Colorado
2009-2012 GMC Canyon

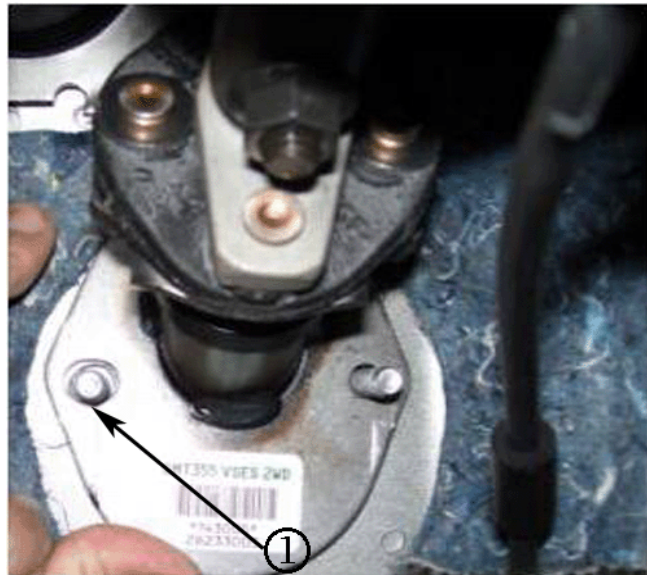
2443279

Some customers may comment on a click or clunk type noise from the steering column only when turning the steering wheel. They also may feel a slight pop from steering wheel or steering column housing.

The cause of this condition may be due to the toe plate stud orientation being at the bottom of the slot (1).
