# Technical Bulletin

01 12 32 November 30, 2012 2031341

**DTC P0441 Stored in the Engine Control Module**

DTC	Description
P0441	EVAP Emission Control System Incorrect Purge Flow

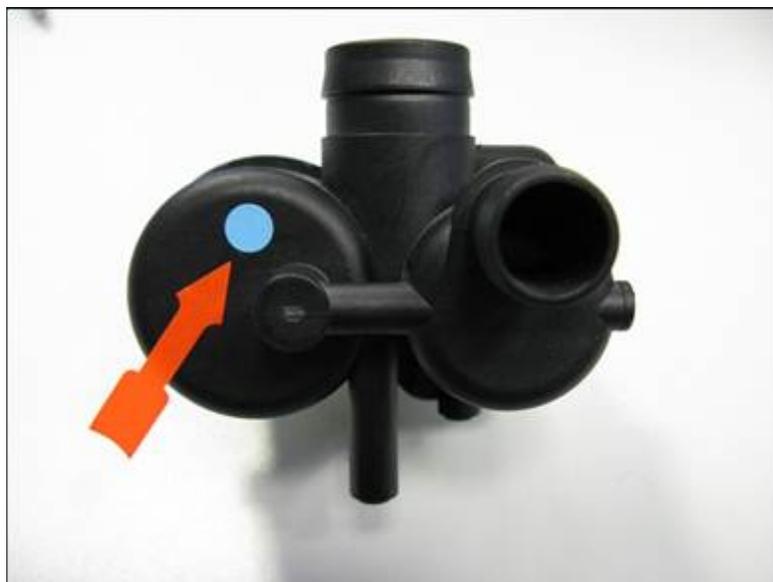
Updated DMTL pumps as of pumps' production date September 2012. (Pumps marked with a dot (color may vary blue, green, white and yellow), implementation dates from plants unavailable at this time).

**Note:**

**Dot color may vary blue, green, white and yellow.**

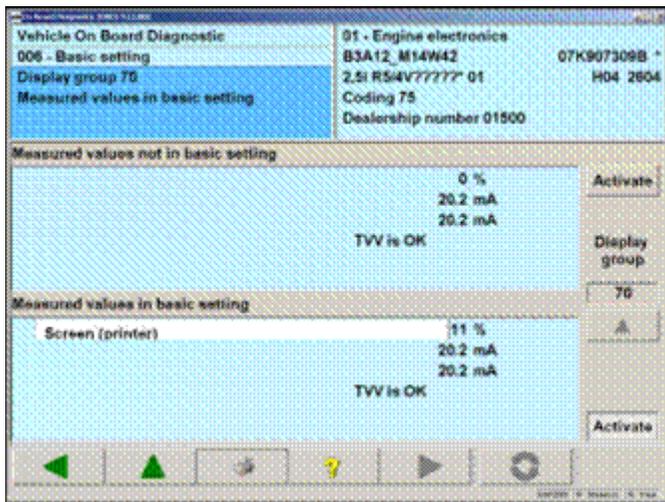
- Check maximum value in row one (lower window).

If maximum value is less than 70%, DMTL is OK, replace the Purge Valve.

If maximum value is greater than 70%, DMTL is not OK and needs to be replaced.

If maximum value is close to 70%, rerun the test 2 more times to get a more accurate reading.
