WC23 - Replacing Vacuum Pump (Workshop Campaign)

Vehicle Type: **Panamera/Panamera 4**

Model Year: **As of 2011 up to 2012**

Concerns: **Vacuum pump**

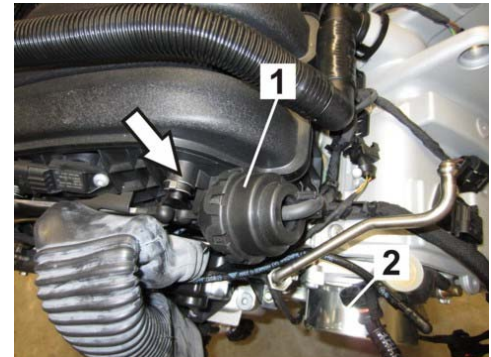
Figure 1

If a vacuum pump is damaged, engine oil can leak out of the vacuum pump through an adjacent duct and get into the vacuum unit for the intake-air distributor switching mechanism and can then leak out of the vacuum unit via the linkage.

The oil can move forward towards the coolant regulator housing on the underside of the intake-air distributor or via various lines routed in this area on the engine and can then be deposited heavily in this area.

The build-up of oil can cause the seals on the coolant regulator housing to swell and coolant can then start leaking out.

- 2 Check the area on the vacuum unit ⇒ *Figure 1-1-* for the intake-air distributor switching mechanism next to the vacuum pump ⇒ *Figure 1-2-* for traces of leaking engine oil ⇒ *Figure 1-arrow-*.

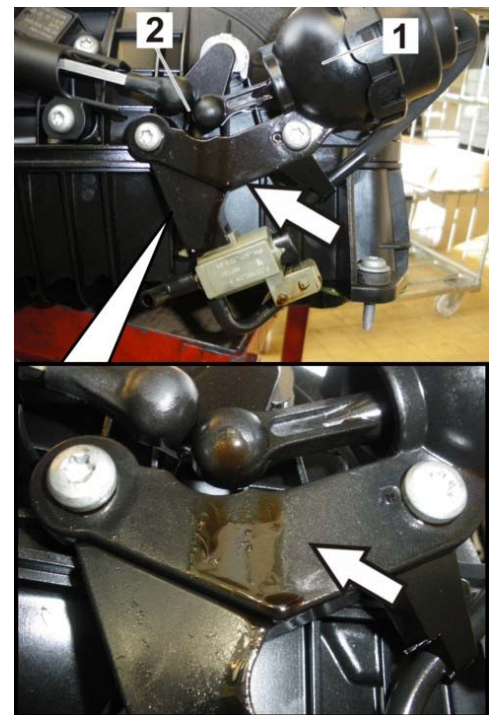
Figure 2

- 3 If the vacuum unit ⇒ *Figure 2-1-* or intake-air distributor switching mechanism ⇒ *Figure 2-item 2-* as shown in ⇒ *Figure 2-arrow-* has visible **traces of oil**, ⇒ **continue** with **Step 4** and **first** replace both seals on the coolant regulator housing (**Scope 3**).

If there are **no** traces of oil on the vacuum unit and on the intake-air distributor switching mechanism, ⇒ **continue** with **Step 5** and install a new vacuum pump (**Scope 2**).

If there are **traces of oil** on the vacuum unit or on the intake-air distributor switching mechanism, in addition to replacing the seals on the coolant regulator housing, **all** components of the vacuum system for the secondary loads (vacuum lines, connections, switching valves) must be checked for **oil leaks**. Vacuum system components that are contaminated with oil must be **replaced**.
