**SERVICE BULLETIN**

**APPLICABILITY:** 2012 and 13MY Impreza and XV Crosstrek™ **NUMBER:** 11-125-12  
 Models Equipped With FB Engine **DATE:** 12/03/12

**SUBJECT:** DTCs P0365, P0366, P0390 and P0391  
 Misfire DTCs P0301, P0302, P0303 and P0304

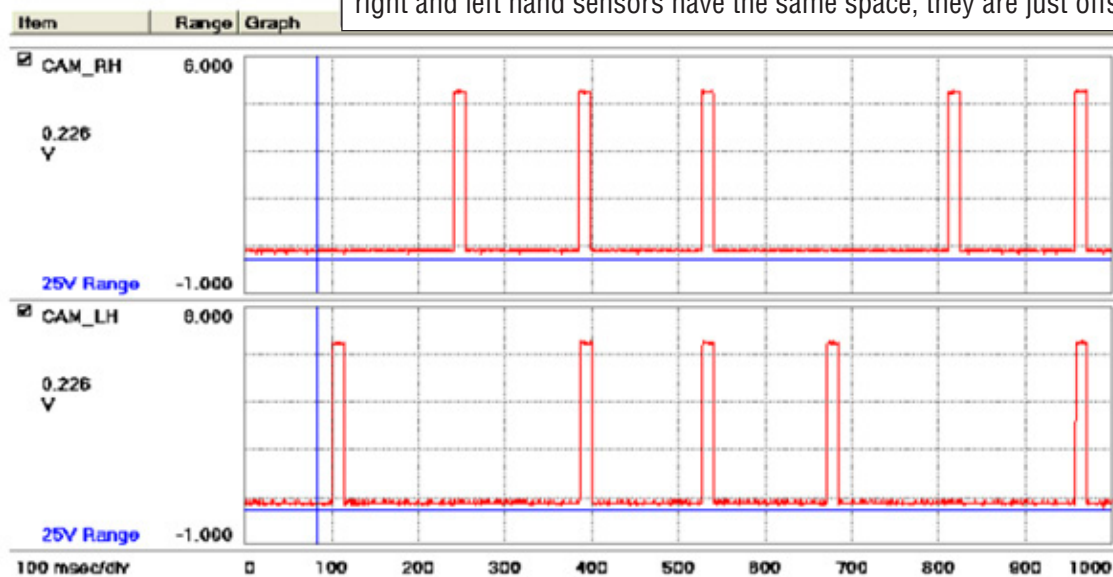
Normal Waveform  
(Normal Pulse)

This example shows a normal reading during the cranking cycle. You will see three peaks equally spaced, then a longer space. Note that the right and left hand sensors have the same space, they are just offset.

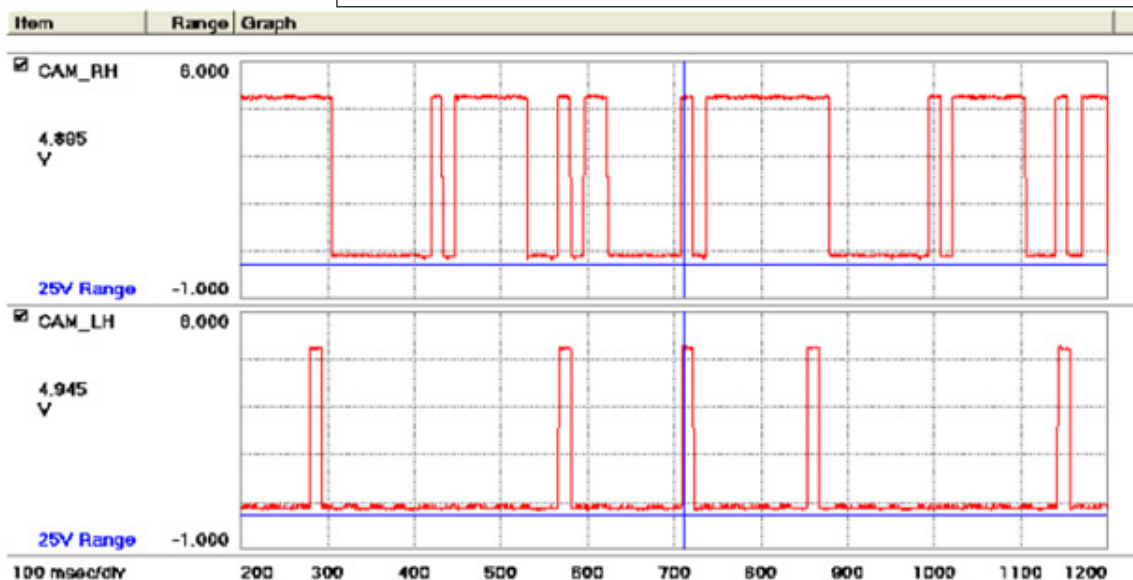
Abnormal Waveform  
(abnormal pulse)

This example shows the right hand sensor has an abnormal reading during the cranking cycle compared to the left hand sensor.

If an abnormal pattern is verified similar to those shown in the illustration above, measure the clearance between the end of the exhaust camshaft position sensor and the sensor plate using the following procedure.

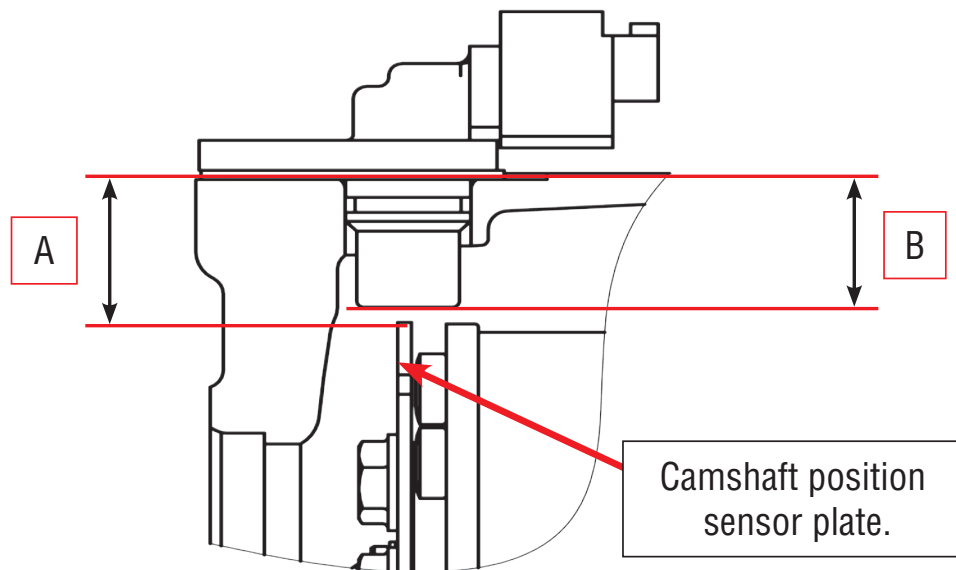
A = Top of timing chain cover to camshaft position sensor plate

B = Camshaft position sensor mating surface to the bottom of the sensor

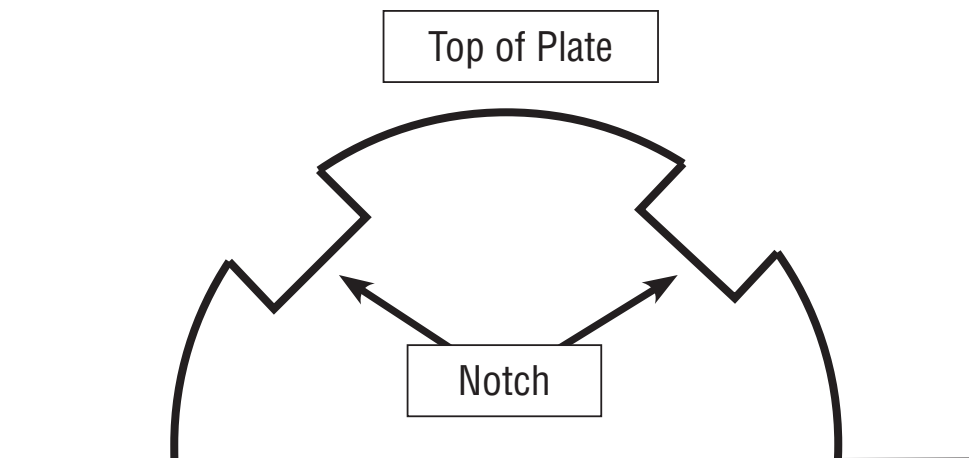
**NOTE:** When measuring “A”, make sure you are measuring to the outside diameter or “top” of the sensor plate and not to the bottom of a notch as shown below. Be sure to record all measurements.

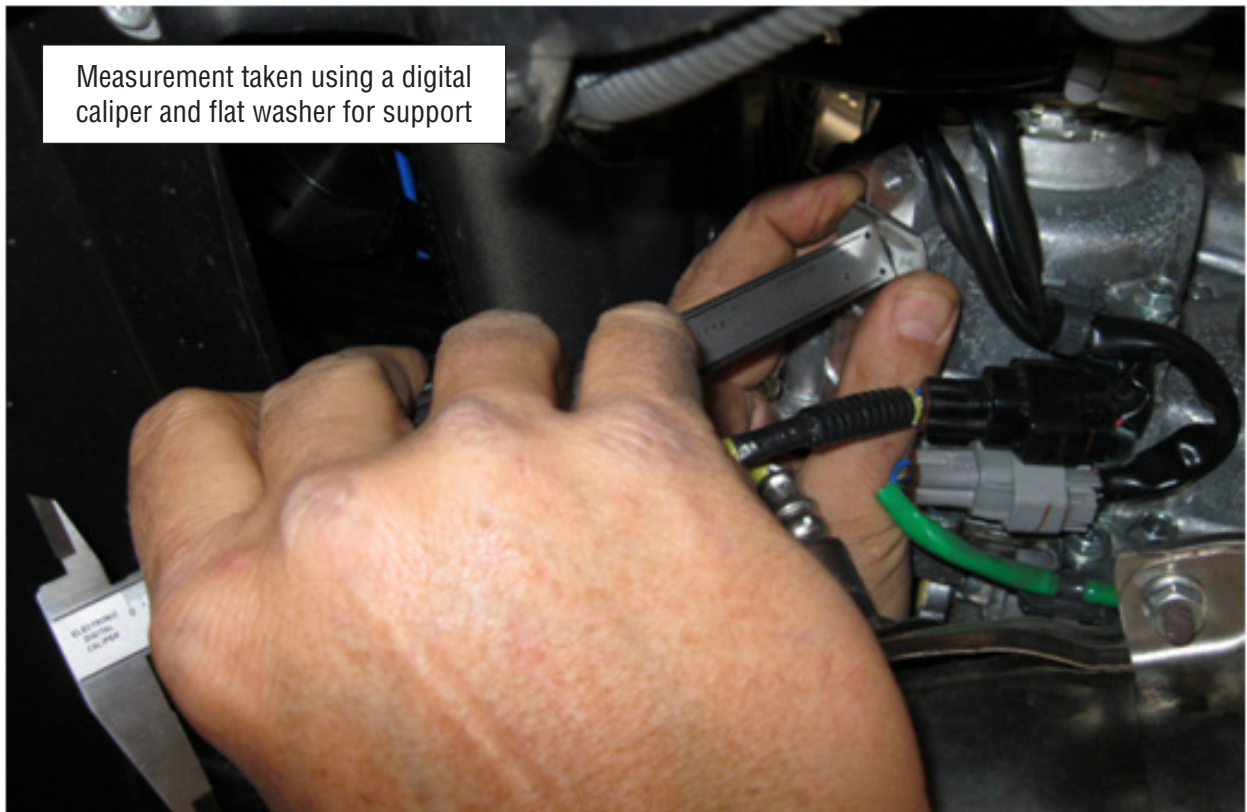
Measurement taken using a digital caliper and flat washer for support

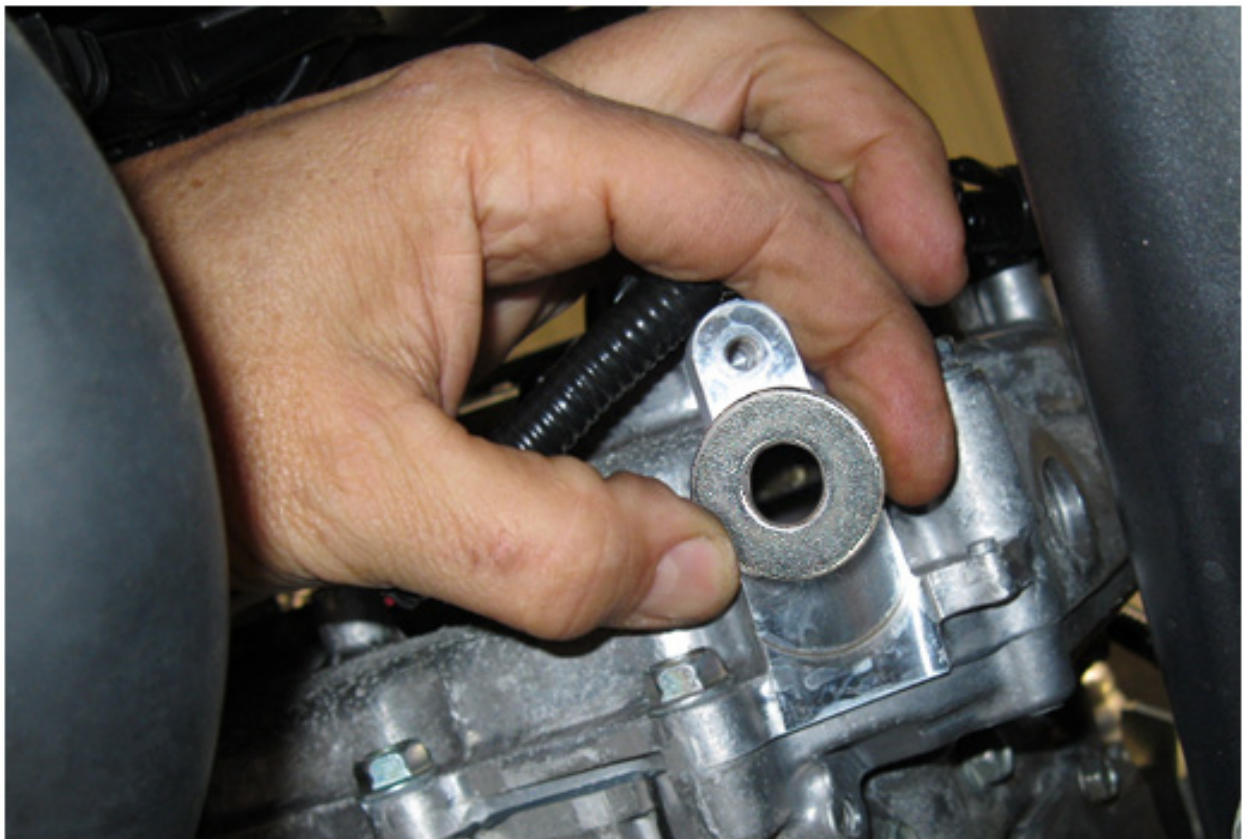
**IMPORTANT:** When using the flat washer for support, make sure it is fully seated on the machined surface of the timing cover as shown in the photo below or your measurements will not be accurate.

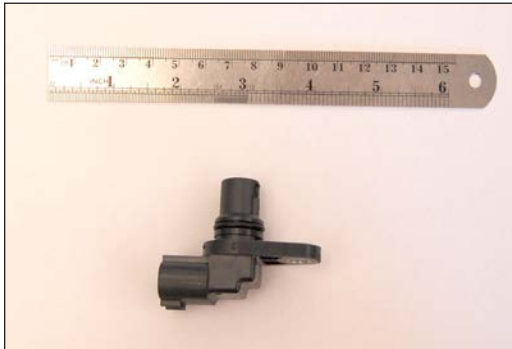
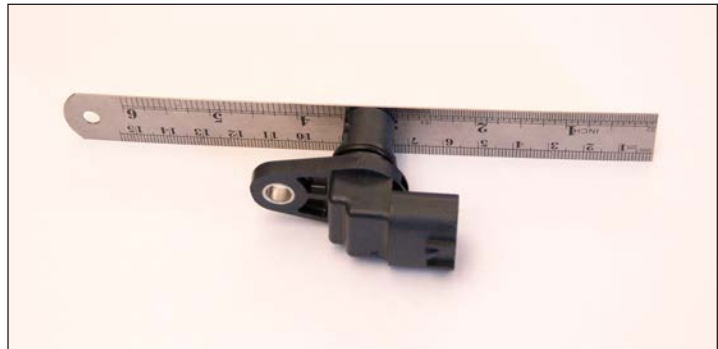
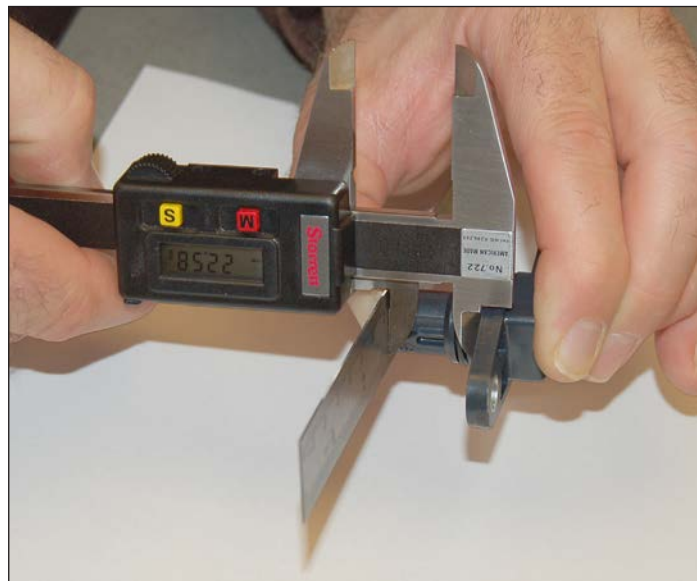
**When taking measurement “B”, use a flat steel ruler or equivalent.**

Measure the camshaft position sensor mating surface (the area that sits flush on the timing chain cover) to the bottom of the sensor and record measurement.
