TECHNICAL SERVICE BULLETIN

TSB#: 12-007

Replace the gas line main quick disconnect valve and test.

Jay Flight; Jay Feather; Eagle
 Replace Disconnect Valve
 12-007

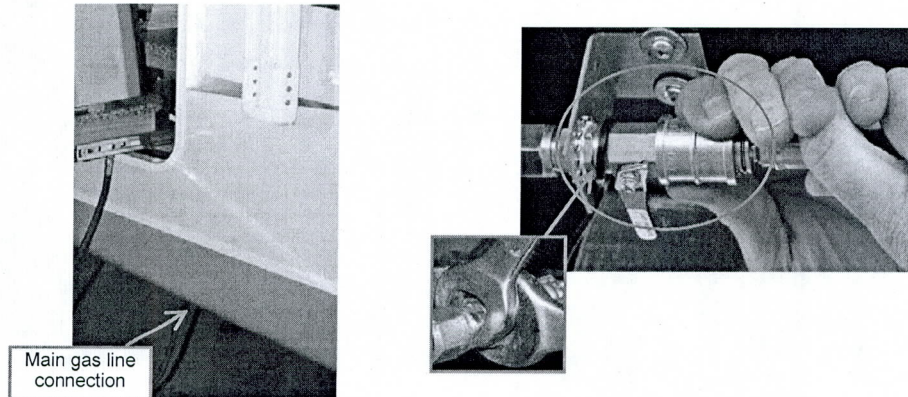
Jayco has determined that on certain model year 2013 Eagle Travel Trailers, Jay Flight Travel Trailers, Jay Flight Bungalows, and Jay Feather Ultra Lite Travel Trailers the exterior grill coupler may not make a proper connection to the fitting for the exterior grill LP line. As a result, the grill will not be able to operate since LP will not flow from the coupler when the valve is opened. To prevent this occurrence, it is necessary to replace the coupler even if the unit was not built with the option for the grill. The coupler is standard equipment.

1. Close all tank valves. Make sure the quick disconnect valve is in the closed position.
2. Locate the main gas line connection. It will be located at the rear door (curb) side of the unit, behind the bottom skirt. The fitting to be replaced is the main gas line quick disconnect valve. Loosen (using 2 open 5/8" & 3/4" wrenches) the quick disconnect valve.
