**PREVOST**ENREGISTRÉ - REGISTERED  
**ISO 9001 & ISO 14001****MAINTENANCE  
INFORMATION**

MI12-40

| DATE : | OCTOBER 2012 | SECTION : | 06 - Electrical |
| SUBJECT : | LOAD DUMP PROTECTION 50DN ALTERNATOR | | |

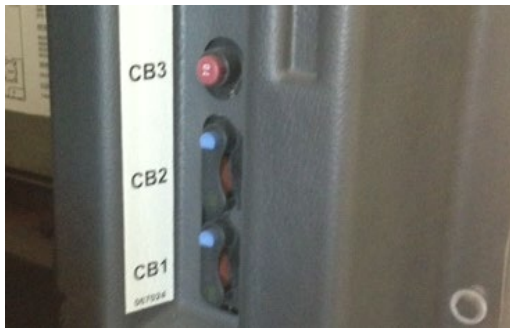
1. Open breakers CB1 & CB2

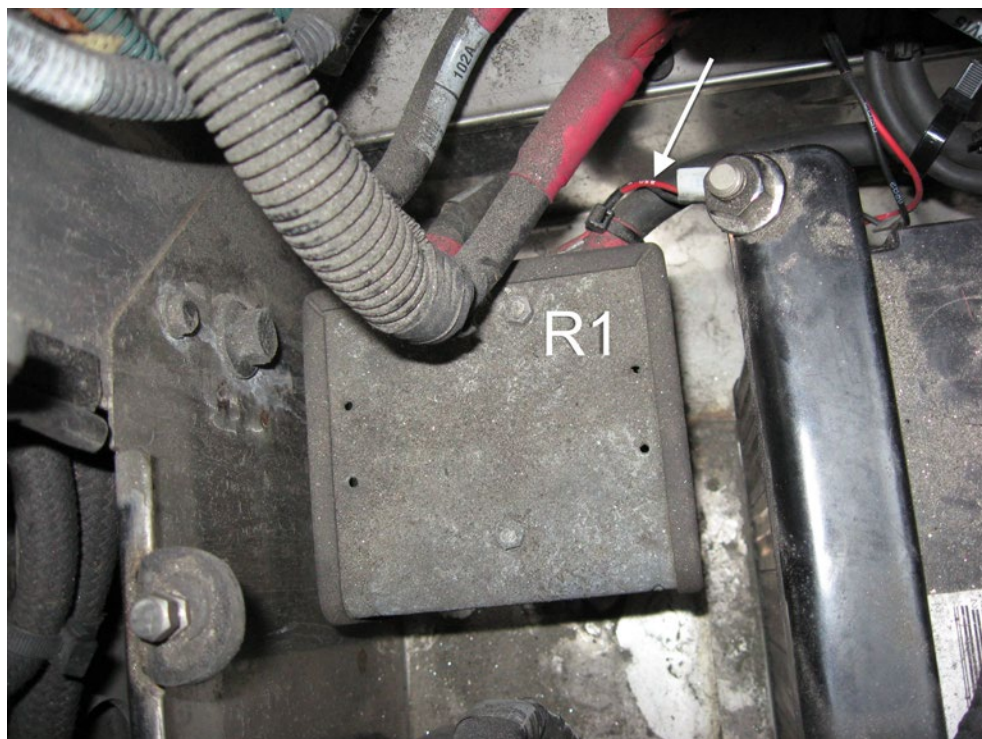
2. Open the battery box cover.
3. Locate wire 24-85G-18 running from R1 relay.

5. At R1 relay, disconnect 85G and cut ring terminal.
6. From pin 86 of R1 relay, run a new 85J red 18ga wire up to SP17.
7. Splice 85J to SP17 using #562228 butt splice and heat shrink tube #562499.
8. Crimp a #560082 ring terminal on 85J, relay side.
9. On existing wire 85G, solder a new diode #561740. Weld and splice other end on wire 85J. Label D62. Protect with translucent heat shrink #562499.

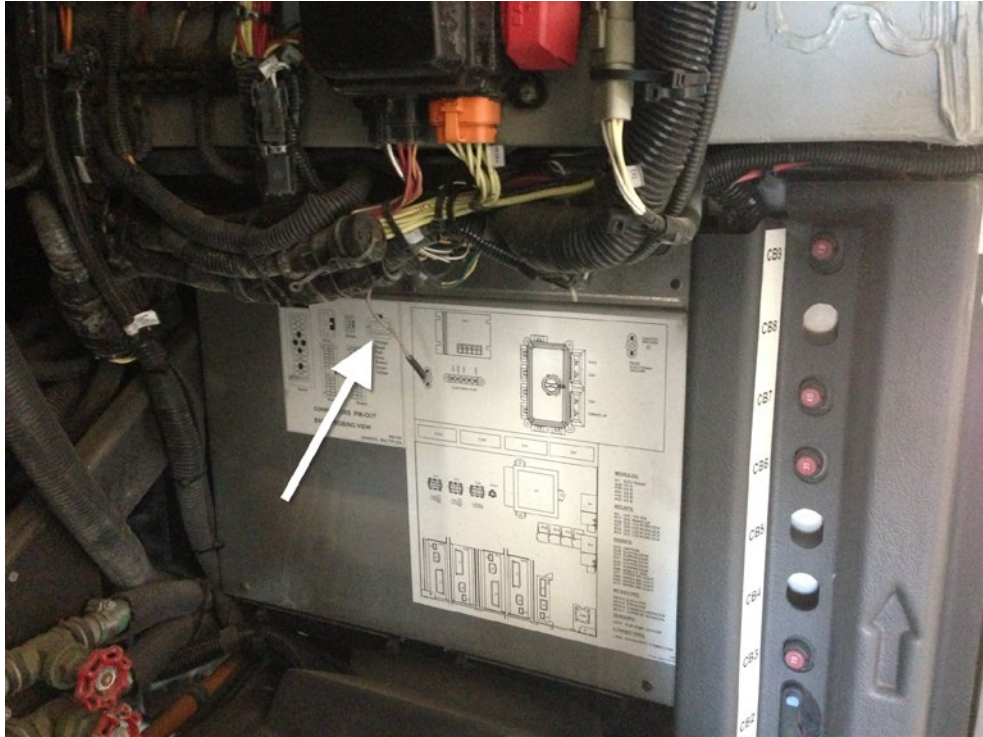
4. Locate SP17, gray spare wire near connector C21.

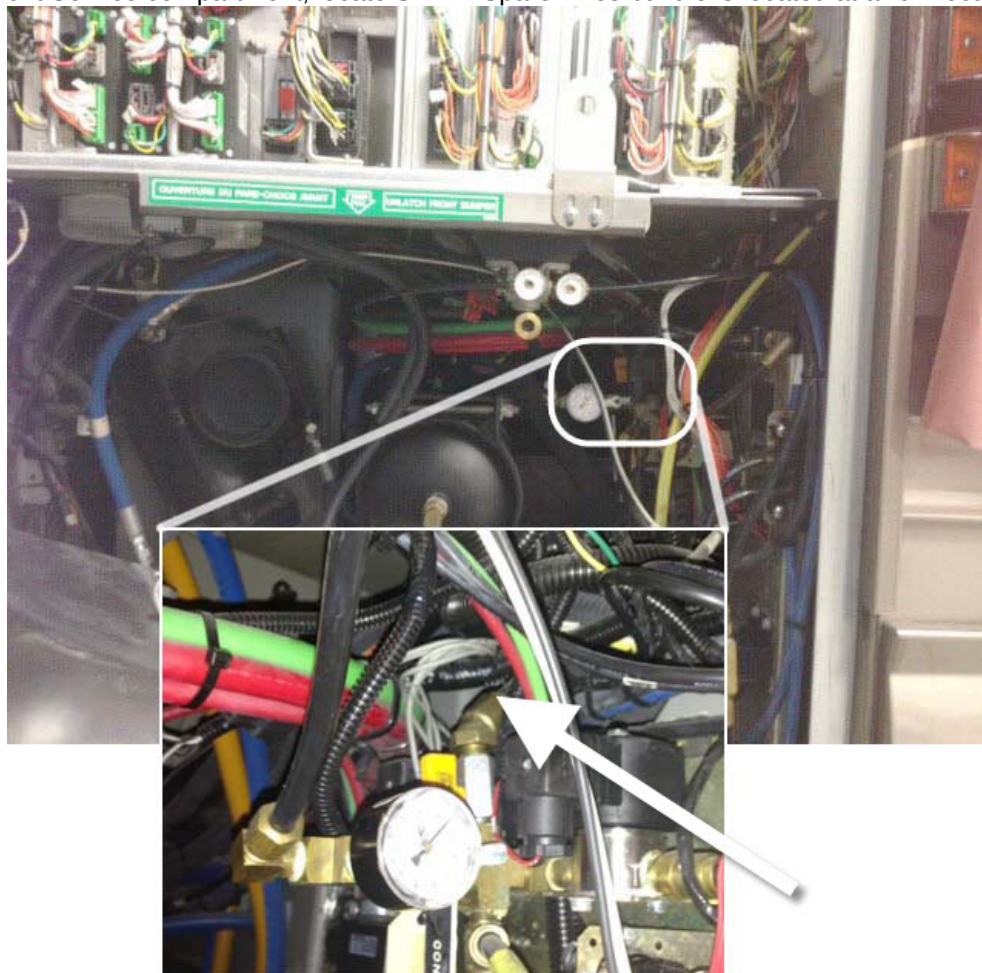
10. In front Service compartment, locate SP17. Spare wires bundle is located at arrow location.

11. Splice a new 85J red 18ga wire on SP17 using #562228 butt splice and heat shrink tube #562499.
12. Connect other end of 85J to JA14 on A36 module. Crimp terminal #562771 with crimper #683765.
13. In the Message Center Display (MCD), verify multiplex software version. (Version should be P17 and later)
14. Follow this menu sequence to verify the software version of the multiplex system.
15. If version is P16 or earlier, reprogram the multiplex to the latest version.
