INTERMITTENT NO START AND/OR ROUGH RUNNING—BLOWN FUSE 13—DTC P0627	TSB 12-11-12
---	---------------------

FORD:
2011-2013 Mustang

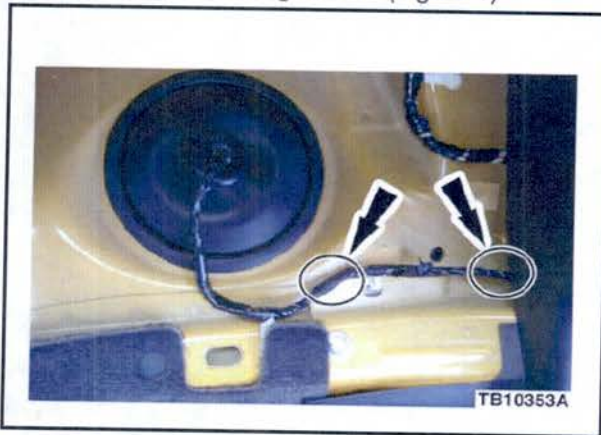
Figure 1 - Article 12-11-12

1. Remove the rear seat cushion. Refer to Workshop Manual (WSM), Section 501-10.
2. Inspect the fuel pump module wire harness for a chafing. Is chafing found? (Figure 1)

- a. No - this article does not apply. Refer to Powertrain Control/Emissions Diagnosis (PC/ED) manual for normal diagnosis.
 - b. Yes - repair the wiring harness. Refer to the Wiring Diagram (WD), Section 5.
3. Route the harness so that it will lie in the recess area of the rear seat when the seat cushion is installed. (Figure 2)
