# MIL "ON" DTC P219A or P219B

Service  
 Category **Engine/Hybrid System**

Section **Engine Control**

Market **USA**

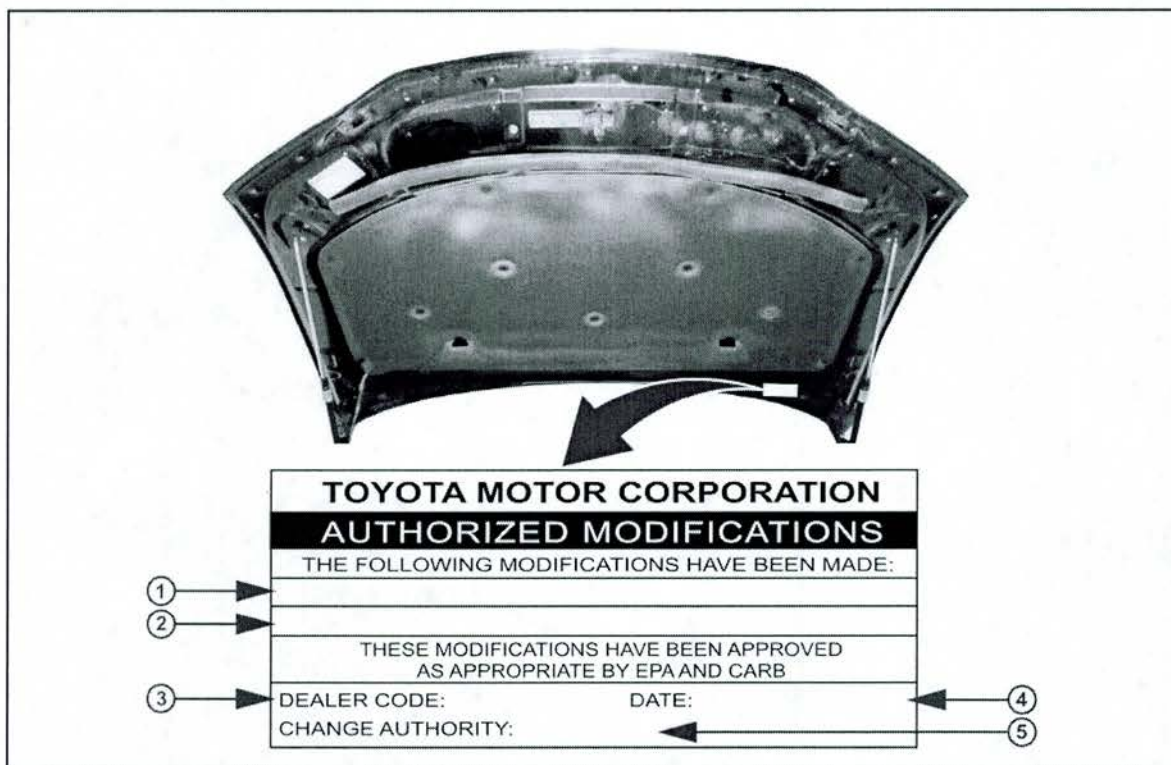
Figure 1. Location of Authorized Modifications Label on 2013 ES 350

1	Replacement ECM (PCM) Part Number (i.e., 89661-33M71)
2	New Calibration ID(s) (i.e., 333D6100)
3	Dealer Code

4	Date Completed
5	This SB Number

B. Affix the Authorized Modifications Label to the vehicle at the location shown in Figure 1 or 2. The Authorized Modifications Label is available through the MDC, P/N 00451-00001-LBL.

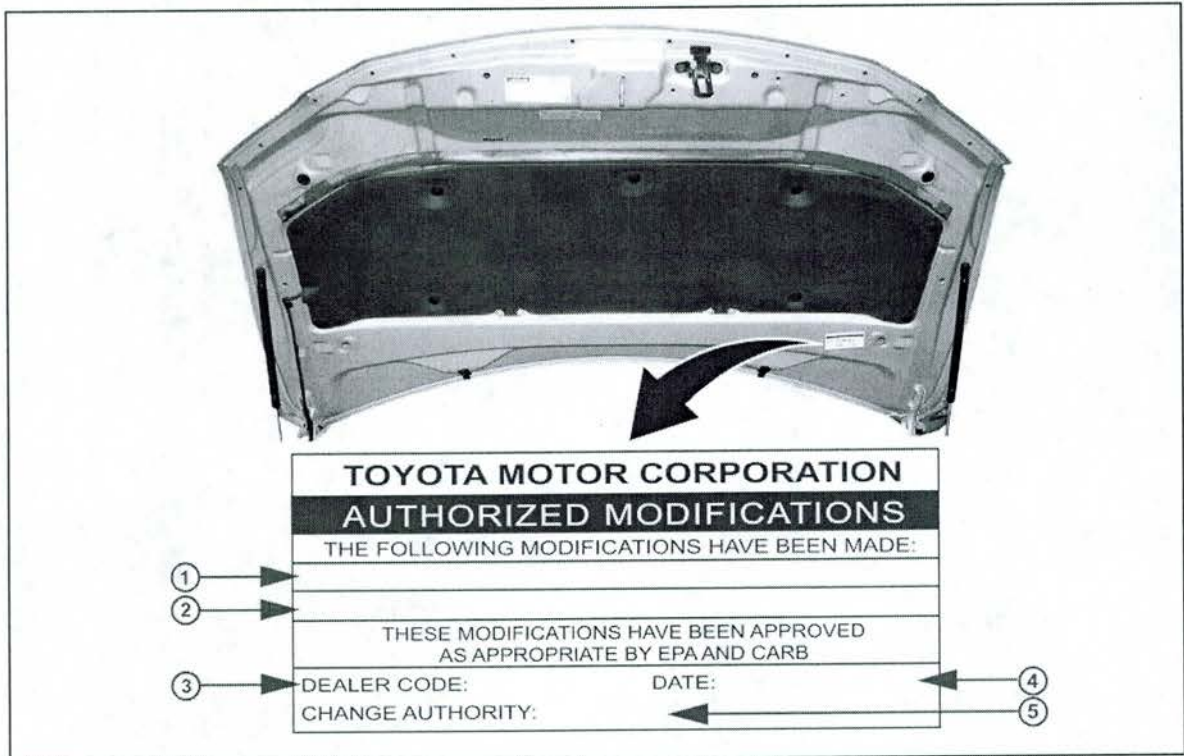
Figure 2. Location of Authorized Modifications Label on 2012 – 2013 RX 350

1	Replacement ECM (PCM) Part Number (i.e., 89661-48J81)
2	New Calibration ID(s) (i.e., 348G9100)
3	Dealer Code

4	Date Completed
5	This SB Number
