© 2012 Mazda Motor of America, Inc.

Subject:**SQUEAK NOISE FROM ENGINE COMPARTMENT****Bulletin No:** 01-021/12**Last Issued:** 11/28/2012**BULLETIN NOTE**

2010-2013 Mazda3 (including 2.0L SKYACTIV)

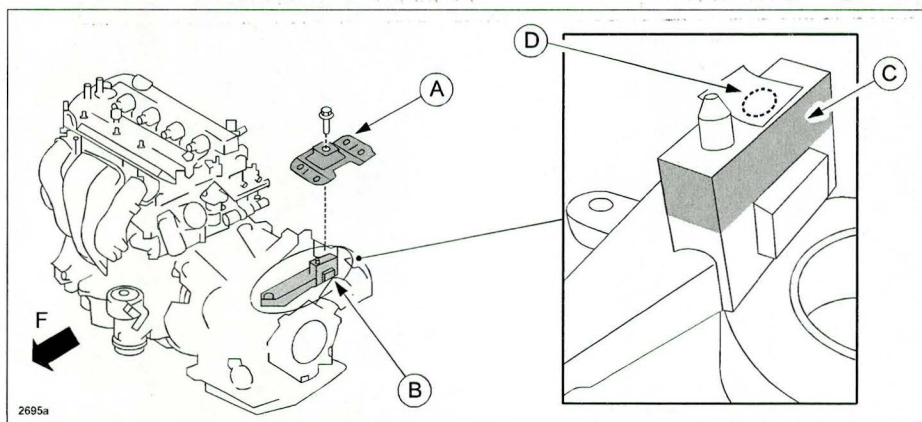
Some vehicles may exhibit a squeak noise from the engine compartment when the vehicle starts moving and/or at the time of transmission shifting. This is caused by stick-slip noise occurring at the contact surfaces between the No. 4 engine mount rubber and the No. 4 engine mount bracket when the engine shakes back and forth. To correct the problem, the No. 4 engine mount is replaced and grease is applied on the contact surfaces of the No. 4 engine mount bracket.

1. Verify customer concern.
2. Remove the No. 4 engine mount rubber (A) from the No. 4 engine mount bracket (B). Refer to MS3 online instructions or Workshop manual section 09-20 ENGINE REMOVAL/INSTALLATION.

3. Clean the surfaces of the No. 4 engine mount bracket (C) where it contacts the engine mount rubber.
4. Place masking tape over the bolt hole (D) of the No. 4 engine mount bracket to prevent grease from entering the hole.
