HYUNDAI NEW THINKING. NEW POSSIBILITIES. Technical Service Bulletin		GROUP	NUMBER
		AUTOMATIC TRANSMISSION	12-AT-009-4
		DATE	MODEL
		NOVEMBER 2012	Tucson (LM), Santa Fe (CM/AN), Sonata (YF), Elantra (UD/MD/GD/JK), Accent (RB), Azera (TG/HG), Veloster Turbo (FS)
SUBJECT:	ATM INPUT AND OUTPUT SPEED SENSOR DTC P0717, P0721 AND P0722

This TSB supersedes bulletin 12-AT-009-3 to include 2013 Santa Fe

Description: Do not replace the transmission for the DTC listed below. Instead, follow the repair procedure and replace the related part.

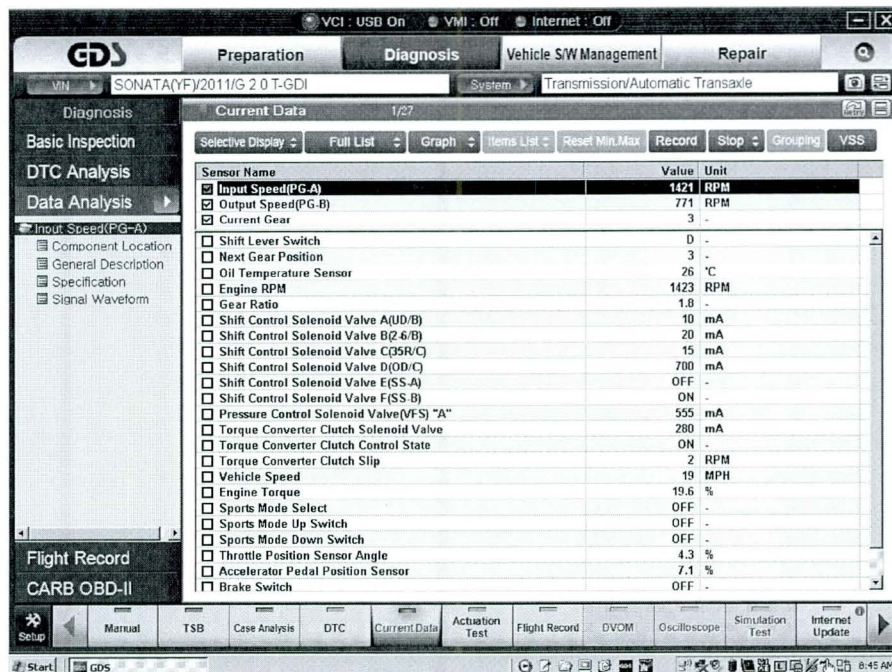
- Using a GDS, check for DTC in the "Automatic Transaxle" menu. **Record the DTC and description.** Delete the DTC.
- From the GDS, select the following parameters. Drive the vehicle and monitor the sensors.
 - Vehicle and A/T menu.
 - "Current Data"
 - Input speed and output speed sensors.

- If the sensors show:
 - Continuous and changing output with changes in vehicle speed, the wiring **currently** has no open/short circuits. Go to Step 5.
 - No continuous and changing output, go to Step 4.
- Visually check the wiring harness between the PCM and transmission for a damaged wire or short circuit to ground. Check for a damaged pin or pin not fully inserted into the connector.
 - If damage exists, repair or replace the ECM control harness and drive the vehicle to confirm the repair.
 - If not, go to Step 5.
- Refer to the DTC recorded in Step 1 and follow the repair procedure shown below:
