HYUNDAI NEW THINKING. NEW POSSIBILITIES. Technical Service Bulletin	GROUP	NUMBER
	AUTOMATIC TRANSMISSION	12-AT-021-1
	DATE	MODEL
	NOVEMBER 2012	Tucson (LM), Santa Fe (CM/AN), Sonata (YF), Elantra (UD/MD/GD/JK), Accent (RB), Azera (TG/HG), Veloster Turbo (FS)
SUBJECT:	AUTOMATIC TRANSAXLE (6-SPEED) OIL TEMPERATURE SENSOR DTC P0711, P0712 & P0713

This TSB supersedes bulletin 12-AT-021 to include the 2013 Santa Fe.

Description: Do not replace the transaxle for the DTC listed below. Instead, follow the repair procedure and replace the related part.

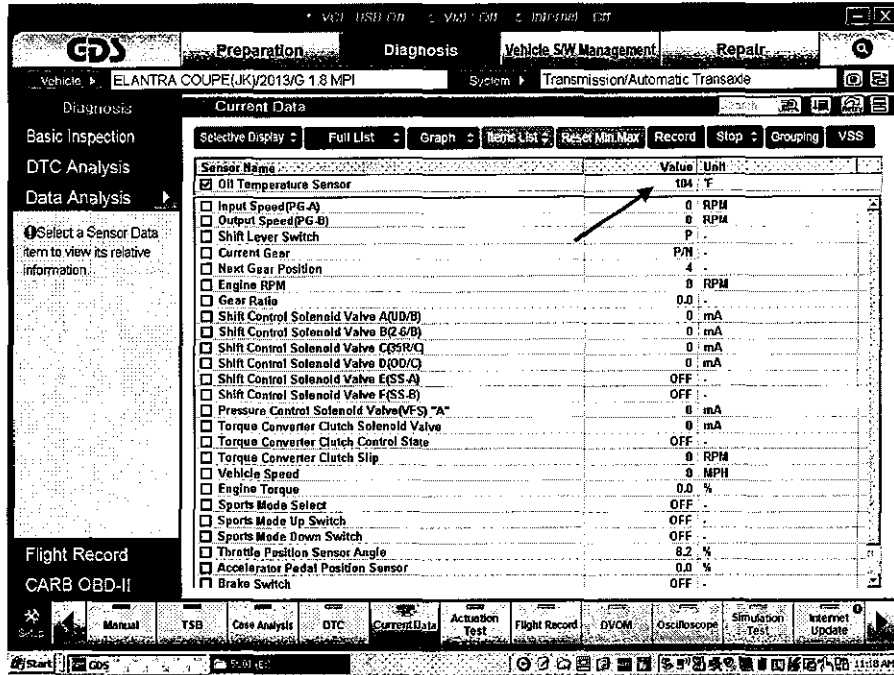
1. Using a GDS, check for DTC in the “Automatic Transaxle” menu. Record the DTC and description. Delete the DTC.
2. From the GDS, select the following parameters. Drive the vehicle and monitor the sensors.
 - Vehicle and A/T menu.
 - “Current Data”
 - Oil temperature sensor.
