HYUNDAI NEW THINKING. NEW POSSIBILITIES. Technical Service Bulletin		GROUP	NUMBER
		AUTOMATIC TRANSMISSION	12-AT-022-1
		DATE	MODEL
		OCTOBER 2012	Tucson (LM), Santa Fe (CM), Sonata (YF), Elantra (UD/MD/GD/JK), Accent (RB), Azera (TG/HG), Veloster Turbo
SUBJECT:	AUTOMATIC TRANSAXLE (6-SPEED) INHIBITOR SWITCH DTC P0705, P0706, P0707 & P0708

This TSB supersedes 12-AT-022 to revise the Parts Information

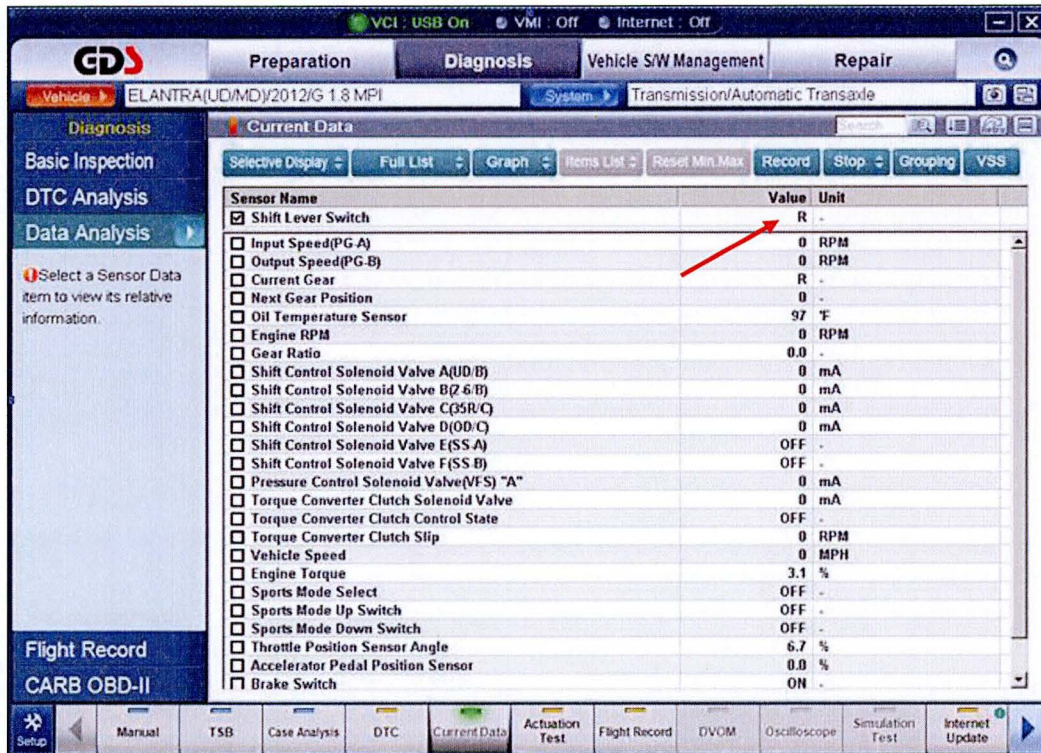
1. Turn the ignition key to the ON position or push the Start/Stop Button two times.
2. Using a GDS, check for DTC in the "Automatic Transaxle" menu. **Record the DTC and description.** Delete the DTC.
3. Select the following parameters. Move the shift lever through all gears and monitor the sensors.
 - Vehicle and A/T menu.
 - "Current Data"
 - Shift Lever Switch.

4. If the Shift Lever Switch shows:
 - The correct shift lever position, the wiring **currently** has no open/short circuits. Go to Step 6.
 - Does not show the correct shift lever position, go to Step 5.
5. Visually check the wiring harness between the PCM and inhibitor switch for a damaged wire or open circuit/short circuit to ground. Check for a damaged pin or pin not fully inserted into the connector.
 - If damage exists, repair or replace the control wiring and drive the vehicle to confirm the repair.
 - If no damage or open/short circuit is found, go to Step 6.
