Campaign No. 2012110003, November 2012

SUBJECT: **Model 218**
Model Year 2012
Retorque the Engine Hood Latch Striker

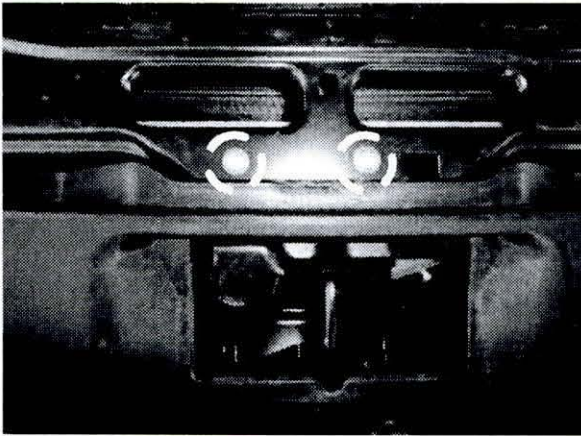
Figure 3

This Recall Campaign has been initiated because Daimler AG (DAG), the manufacturer of Mercedes-Benz vehicles, has determined that due to incorrect technical documentation, the bolts securing the striker for the engine hood latch might have been tightened with reduced torque in the subject vehicles. The engine hood is secured with one lock on the left side and one lock on the right side. If only one of these locks is engaged, the engine hood will remain safely secured. If the engine hood is not properly closed and both locks are not engaged, an additional securing mechanism is provided by the engine hood latch. The driver is made aware of this condition by a warning message in the instrument cluster indicating the engine hood is not properly closed. If the driver were to disregard this warning message and if at least two bolts of the striker for the engine hood latch are loose, the engine hood has no securing mechanism and could open while driving, thus increasing the risk of a crash.

3. Retorque 4 bolts (Circled, Figures 3 and 4) of engine hood striker to: 10 Nm.

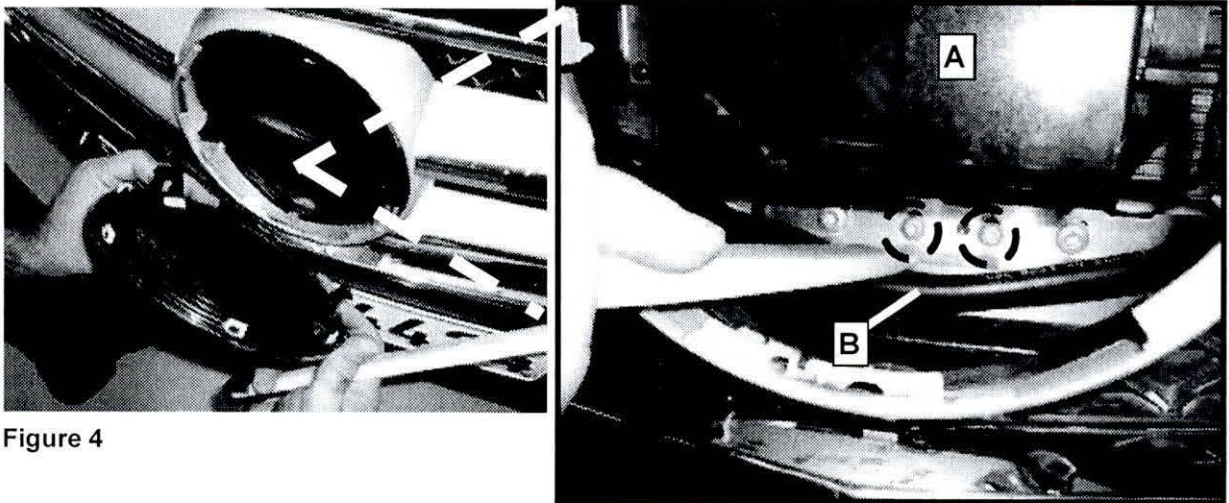
Figure 4

Lower striker bolts (circled, Figure 4) are located below Distronic sensor (A) behind rubber hose (B).
