GROUP  
Electrical  
NUMBER  
046 (Rev 1, 12/13/2012)

MODEL  
Rio (UB) 2013MY  
DATE  
November 2012

## TECHNICAL SERVICE BULLETIN

SUBJECT: SERVICE ACTION: UVO SOFTWARE UPGRADE (SA137A)

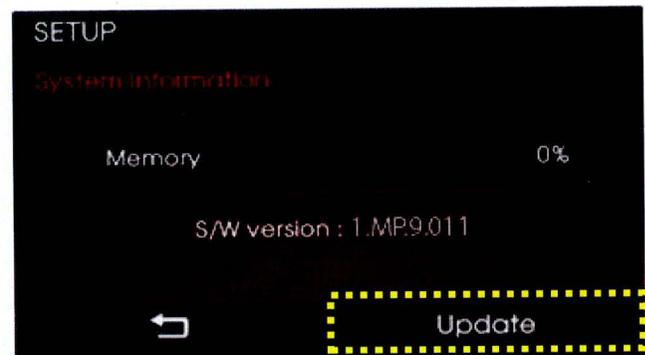
- 13a. Verify the current S/W version (1.MP.9.011) as shown in the image.

- 13b. Touch **“Update”** button on screen.

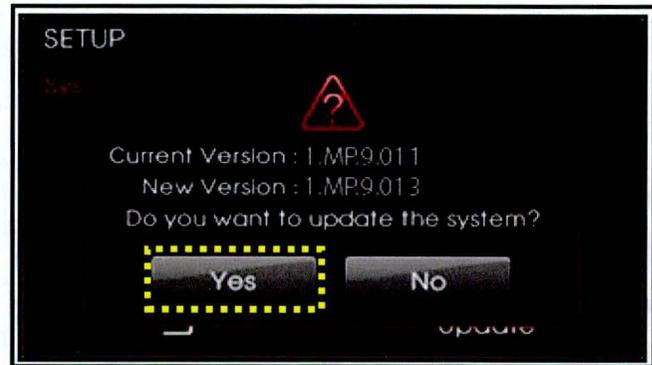
14. Check that “**New Version**” is correct for this Service Action (New version is 1.MP.9.013); if version is correct, then touch “**Yes**” button on screen.

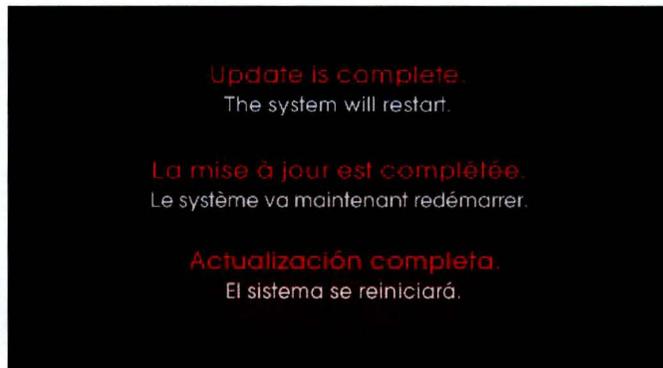
16. After the update is complete, the display shown on the right will appear for a few moments; then the UVO system will reboot again.

Repeat steps 2~4 and verify whether UVO system version has been updated to version 1.MP.9.013.
