GROUP Body	MODEL Optima (TF/QF) 2011~13MY
NUMBER PS226	DATE November 2012

**SUBJECT:** PANORAMA SUNROOF TRIM SEAL LOOSE

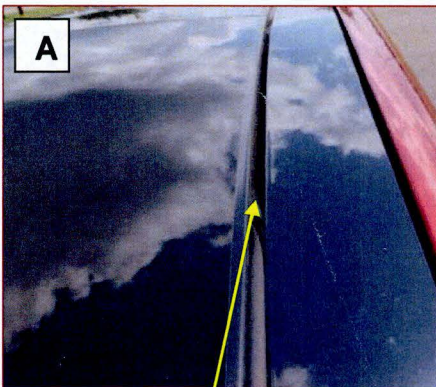
Optima's produced from SOP to October 24, 2012, equipped with Panorama Sunroof option, may exhibit a loose or sagging side trim seal (A). A portion of the side trim seal may become detached and caught under the sunroof, as it is closed, causing poor appearance and improper sealing.

Side seal caught under sunroof.
