GROUP Electrical	MODEL Sportage (SL) 2013MY
	NUMBER 048 (Rev 1, 12/13/2012)	DATE November 2012
TECHNICAL SERVICE BULLETIN		
SUBJECT: SERVICE ACTION: UVO SOFTWARE UPGRADE (SA139A)

SUBJECT: SERVICE ACTION: SPORTAGE (SL) UVO SOFTWARE UPGRADE (SA139A)

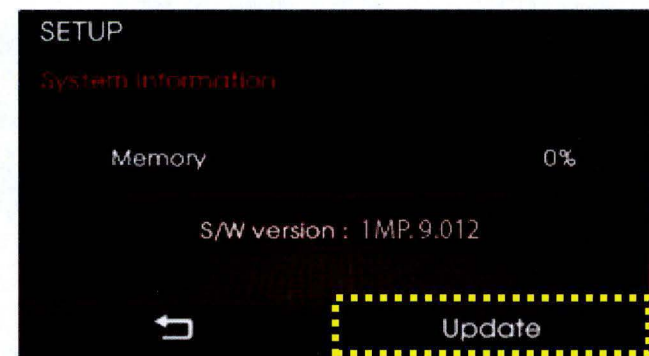
- 13a. Verify the current S/W version (1.MP.9.011) as shown in the image.

- 13b. Touch **"Update"** button on screen.
