GROUP Electrical	MODEL 2013MY Rio (UB)
NUMBER 050	DATE November 2012

## TECHNICAL SERVICE BULLETIN

SUBJECT: SERVICE ACTION: AVN SOFTWARE UPGRADE (SA133)

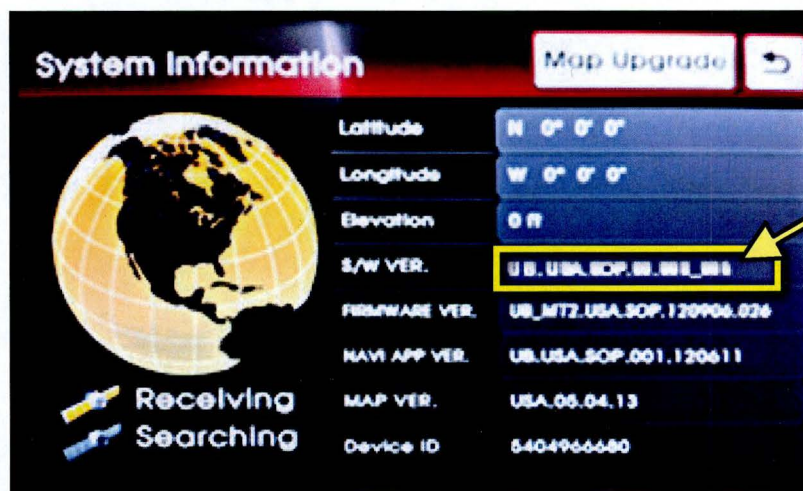
This bulletin describes the procedure to update the navigation system software and modify the phone pairing logic in 2013MY Rio vehicles, with navigation system (AVN) and manual transmission, produced From June 12, 2012 to Aug. 29, 2012. Verify navigation system software version by referring to the table below; then follow the procedure outlined in this TSB to update the navigation system. Kia is requesting the completion of this Service Action on all affected vehicles in dealer stock prior to delivery. Before conducting procedure, verify that the vehicle is included in the list of the affected VINs.

OLD S/W VERSION:	UB_USA.SOP.00.008_006
NEW S/W VERSION:	UB_USA.SOP.00.014_MT2

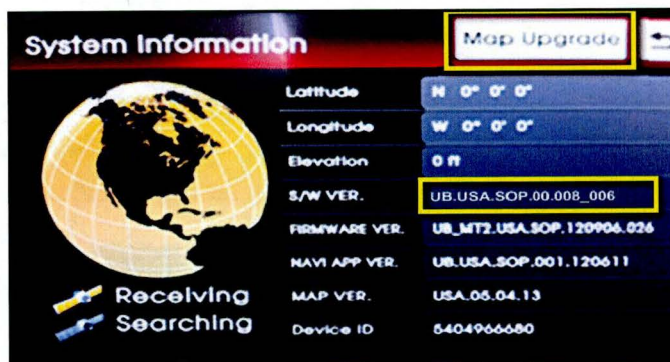
**\*NOTICE**  
Verify current software version is **“UB.USA.SOP.00.008\_006”**

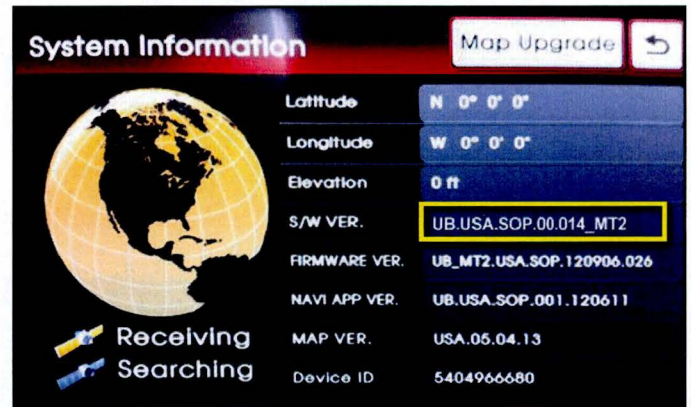
22. Verify new software version is **UB.USA. SOP.00.014\_MT2.**
