MODEL
Sorento (XM) 2.4L
GDI 2013MY

NUMBER
126

TECHNICAL SERVICE BULLETIN

SUBJECT: ALTERNATOR PULLEY AND
TENSIONER REPLACEMENT

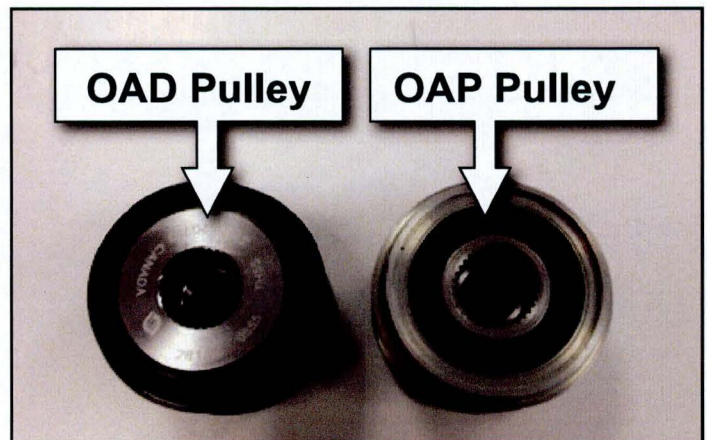
2. Inspect the alternator pulley to confirm the specific type of pulley installed on the vehicle. If the vehicle is equipped with the Original Alternator Dampening Pulley (OAD) (see identification chart below), perform the procedure outlined in this TSB.

Pulley Identification Chart	
Pulley Type	Body Color
OAD	Black
OAP	Silver

***NOTICE**
If the vehicle is equipped with the Overrunning Alternator Pulley (OAP), proceed with re-flash procedure only.
