2nd Row Tip-Up Style Seat Lower Cushion Excessive Movement

Service Category Vehicle Interior

YEAR(S)	MODEL(S)	ADDITIONAL INFORMATION
2011 – 2014	Sienna

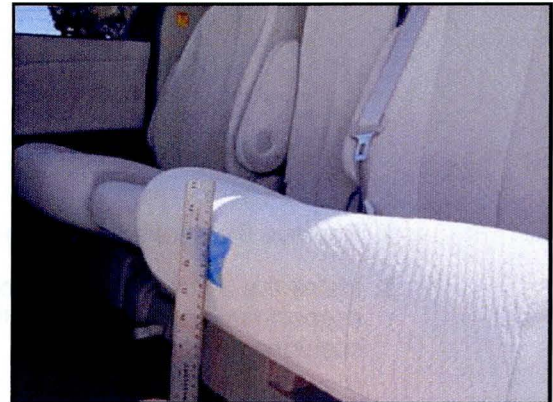
Figure 1. Example of Seat Measurement

1. Confirm amount of lower seat cushion movement.
 - A. Latch the lower seat cushion into place.
 - B. Apply downwards pressure at the center of the lower seat cushion to verify the amount of movement present in the seat cushion frame assembly.
2. While applying pressure, measure the amount of movement in the lower cushion assembly.
 - A. Apply tape to the front edge of the cushion.
 - B. Draw a reference line on the tape.
 - C. Using a metric ruler, measure vertical movement of the lower cushion.

MEASUREMENT	INSPECTION RESULT	REPAIR	OP CODE
0 – 3 mm	Normal characteristic (within specification)	None	None
4 – 12 mm	Excessive movement	Repair Procedure 1	BD1223
13+ mm	Seat latch mechanism damaged (replacement required)	Repair Procedure 2	See table in Repair Procedure 2, step 2

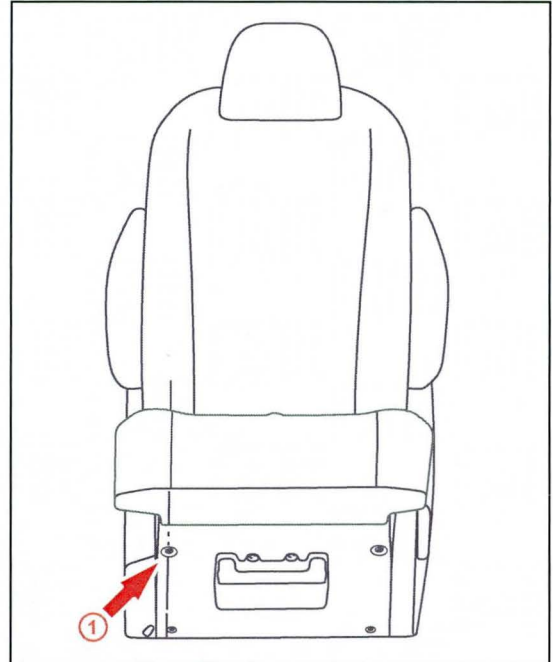
Figure 2.

1	Seat Support Cushion
---	----------------------

1. Tip up lower cushion to gain access to the seat support cushions.

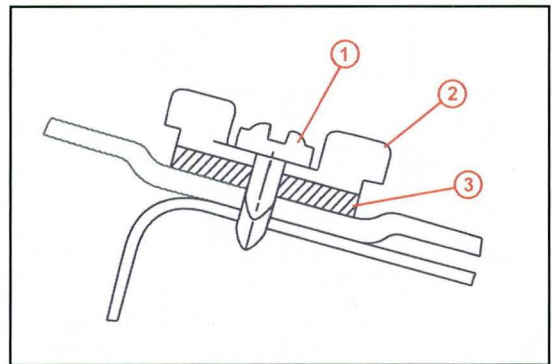
Figure 3.

1	Screw
2	Seat Support Cushion
3	Shim

2. Remove the seat support cushions and screws.
3. Install the 3 mm shim to the bottom of the seat support cushions and reinstall the seat support cushions and screws.

For vehicles built before 12/2011, a new seat support cushion and screw are required to properly install the 3 mm shim.
