# Integration Relay Poor Ground

YEAR(S)	MODEL(S)	ADDITIONAL INFORMATION
2013	ES300H	
2013	ES350

Some 2013 model year ES 350 and ES 300h vehicles may exhibit a condition where the passenger headlight and rear defogger operate continuously.

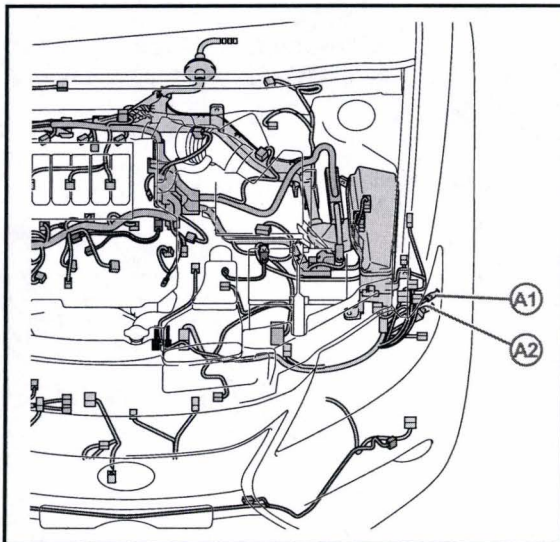
Figure 1.

- Has the vehicle had body work or the A1/A2 grounds, or apron mounting bolts disconnected?
  - YES / UNSURE** — Continue to step 2.
  - NO** — This bulletin does NOT apply. Continue diagnosis using the applicable Repair Manual.

A1	A1 Ground
A2	A2 Ground

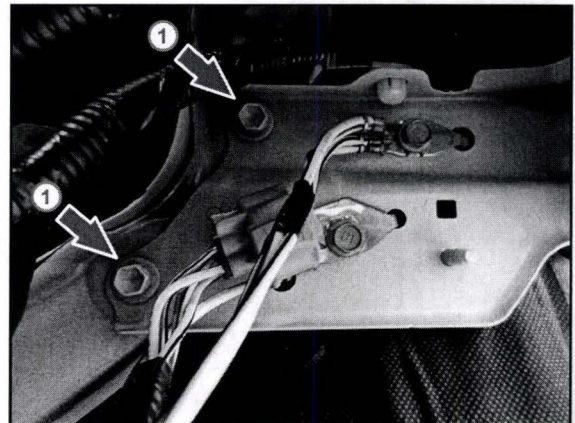
Figure 2.

1	Apron Bolts
---	-------------

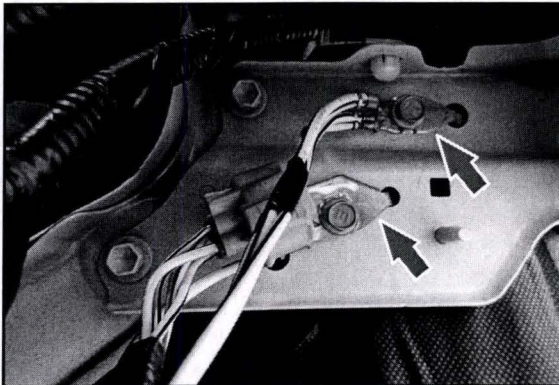
Figure 3.

7. Perform voltage drop test\* from the two left fender bracket ground wire eyelet tabs to body ground (see Figure 3).

8. Is voltage drop from each ground location less than 0.2 volts?
  - **YES** — This bulletin does NOT apply. Continue diagnosis using the applicable Repair Manual.
  - **NO** — A voltage drop of 0.2 volts or more from either of the ground locations may indicate poor continuity in the ground circuit. Proceed to step 9.
9. With battery disconnected, remove the left hand fender bracket from the apron for inspection.

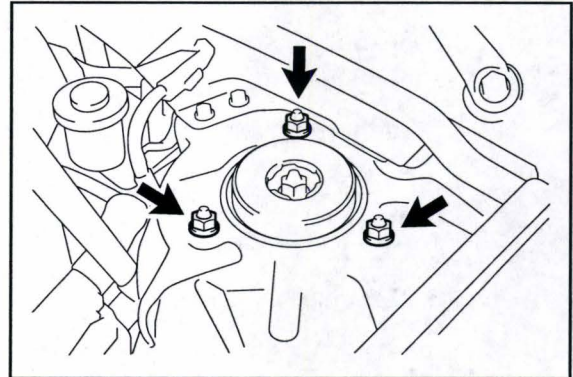
Figure 4.

- A. Use a left front strut tower mounting bolt as a good body ground (see Figure 4).
- B. To perform voltage drop test, connect the negative lead of the DVOM to the strut tower bolt, and the positive lead to the ground wire eyelet tab.

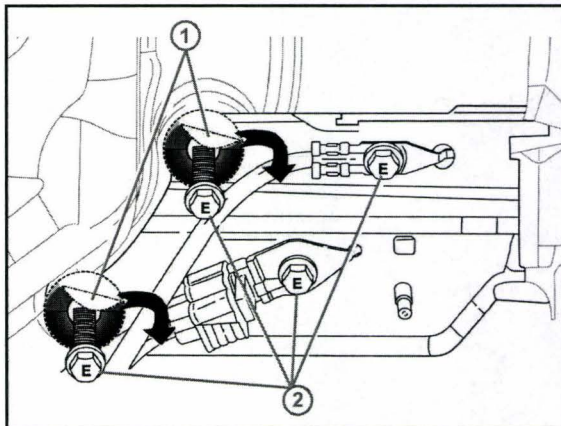
Figure 5.

- Ground bolts are "E" bolts (see Figures 5 and 7).
- Apron bolts should be "E" bolts if left hand fender bracket has been replaced (see Figures 5 and 7).
- The area around the bracket to apron mounting bolt holes (see Figure 6) is free of paint.
- The area around the apron mounting bolt holes do not show masking tape or painted masking tape (see Figures 5 and 6).

1	Confirm Green Masking Tape Is Removed
2	Confirm "E" Bolts Are Installed

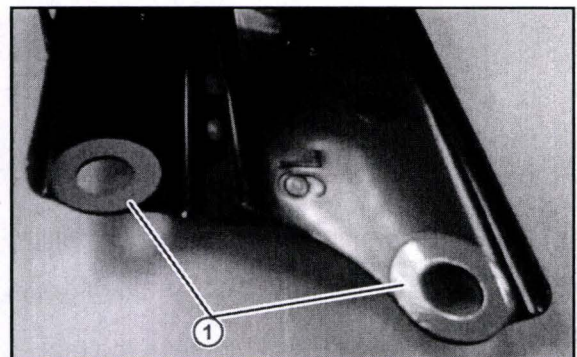
Figure 6.

1 Masking Tape — REMOVE After Painting, NO Paint in This Area

- **NO** — Replace the left hand fender bracket.
- **YES** — Remove the tape or paint and continue to step 12.

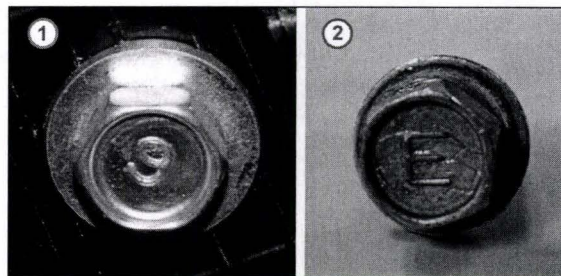
Figure 7.

1	Old Bolt: DO NOT USE or Reuse These Bolts
2	NEW "E" Bolt

- It is important that the bracket to apron mounting bolts/washers are free of paint on the front portion of the bracket.
- The new part number bracket comes with instructions that should be followed carefully when replacing.
- The new bracket also comes with green tape around the apron mounting bolts to protect it during the painting phase (see Figures 5 and 6). *This green masking tape MUST be removed in order for the bracket to be properly installed on the vehicle.*
- The new bracket includes new apron "E" mounting bolts. It is important that the new "E" bolts are used and are torqued properly. See Figure 7 on how to identify new bolts.

**Torque: Ground Bolts:**  
 6.9 – 9.8 N\*m (70 – 100 kgf\*cm,  
 5.1 – 7.2 ft\*lbf)

**Torque: Bracket to Apron Bolts:**  
 3.9 – 8.8 N\*m (40 – 90 kgf\*cm,  
 2.8 – 6.5 ft\*lbf)
