Subject: UNABLE TO LOWER REAR SEATBACK WITH REMOTE HANDLE / SEATS HARD TO LOCK	Bulletin No: 09-042/12
	Last Issued: 11/07/2012

2013 CX-5 vehicles equipped with a 4:2:4 split type rear seat with VINs lower than JM3KE*****192961 (produced before Jan. 20, 2012)

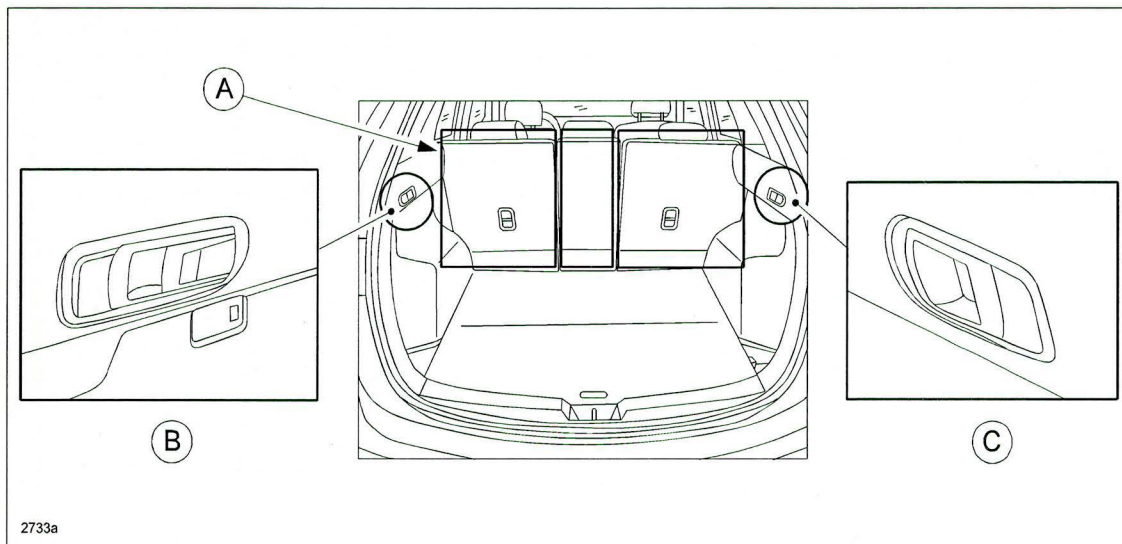
Some vehicles equipped with a 4:2:4 split type rear seat may be unable to lower the rear seatback (A) when pulling the left (B) and/or right (C) remote handles. Also, the seatbacks may not fully latch (lock) when placed in the upright position.

This concern may be caused by an incorrect seatback remote cable adjustment position. The current adjustment position may not provide enough tension for the cable to unlock the seatback latches.

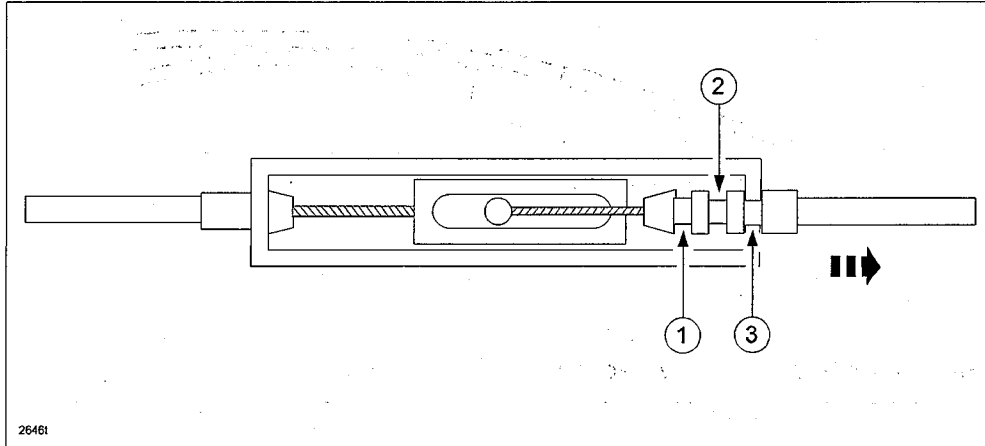
NOTE: Cable adjustment setting position "3" is the factory setting for vehicles produced before Jan. 20, 2012.

- Using a small flathead screwdriver, pop open the affected remote cable adjuster housing and check the current cable adjustment setting position (1, 2 or 3) as shown below.
