# Service Bulletin

<b>Subject:</b> <b>DRIVER-SIDE MIRROR VIBRATION WHEN DRIVING ON ROUGH ROAD OR HIGHWAY</b>	<b>Bulletin No:</b> 09-044/12
	<b>Last Issued:</b> 11/20/2012

2010-2012 CX-9

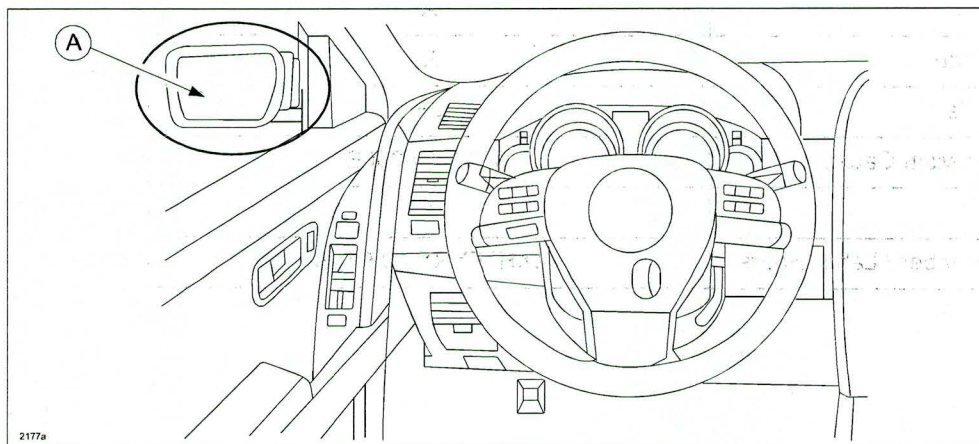
Some vehicles may exhibit a vibration on the driver-side rear view mirror (A) when driving on a rough road or highway. The mirror vibration may get worse when vehicle speed is over 65mph (105Km/h). During these conditions, customers may complain that the driver-side rear view mirror is difficult to see.

The following repair procedures have been developed to reduce vibration concern.
