SERVICE BULLETIN RELEASE - 11/28/2012

Subject: PANDORA FUNCTION FOR AUDIO SYSTEM IS NOT AVAILABLE	Bulletin No: 09-045/12
	Last Issued: 11/28/2012

2013 Mazda3 vehicles (with Navigation) with VINs lower than JM1BL*****743201 (produced before October 22, 2012)

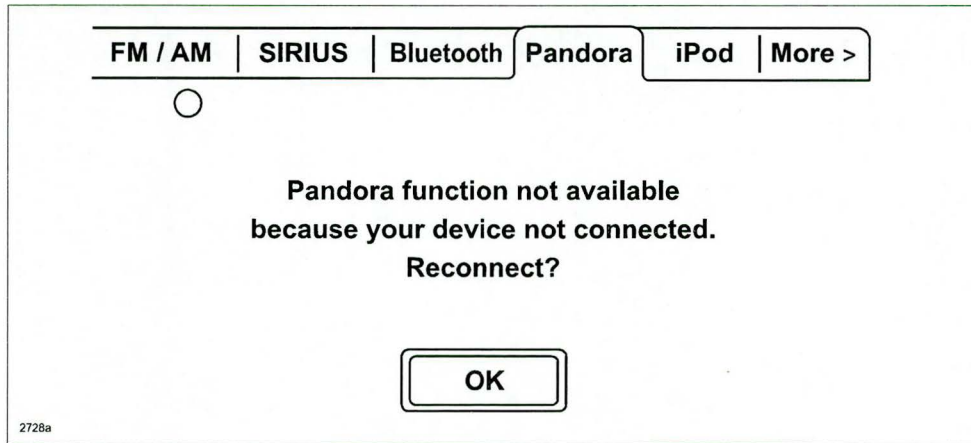
Some vehicles may experience that Pandora gets disconnected with a message as shown. This happens when Pandora is playing via Bluetooth and an iPhone/iPod, etc. is connected or disconnected from the USB terminal. To get Pandora to play again, the Pandora application needs to be restarted. This is caused by improper software of the Bluetooth unit. To correct the problem, the software of the Bluetooth unit has been changed.

Customers having this concern should have their vehicle repaired using the following repair procedure.
