# Abnormal Chirp or Squeak Noise from High Pressure Fuel Pump

Service Category Engine/Hybrid System

Section Fuel System

YEAR(S)	MODEL(S)	ADDITIONAL INFORMATION
2013 – 2014	FR-S

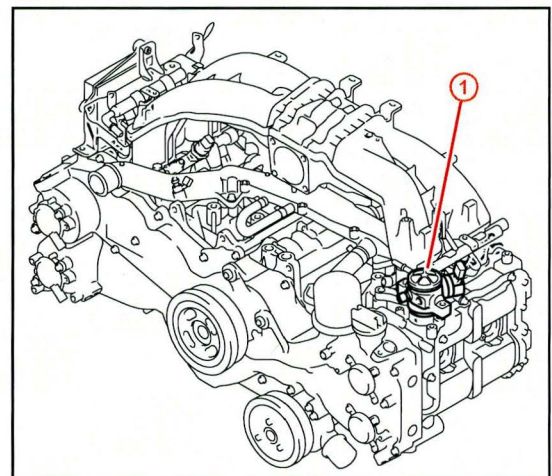
Figure 1.

Some vehicles may exhibit a high pitch chirp or squeak noise from the High Pressure Fuel Pump Assembly when the engine is fully warmed up and idling. Follow the procedure in this bulletin to address this condition.

<b>1</b>	<b>Fuel Pump Assembly (for High Pressure)</b>
----------	---

- **YES** — Continue to step 4.
  - **NO** — This bulletin does NOT apply. Continue diagnosis using the applicable Repair Manual.
4. Replace the High Pressure Fuel Pump Assembly.
