HYUNDAI NEW THINKING. NEW POSSIBILITIES. Technical Service Bulletin	GROUP BODY	NUMBER 12-BD-002
	DATE DECEMBER 2012	MODEL(S) TUCSON (LM)
SUBJECT: OUTSIDE REAR VIEW MIRROR REPAIR

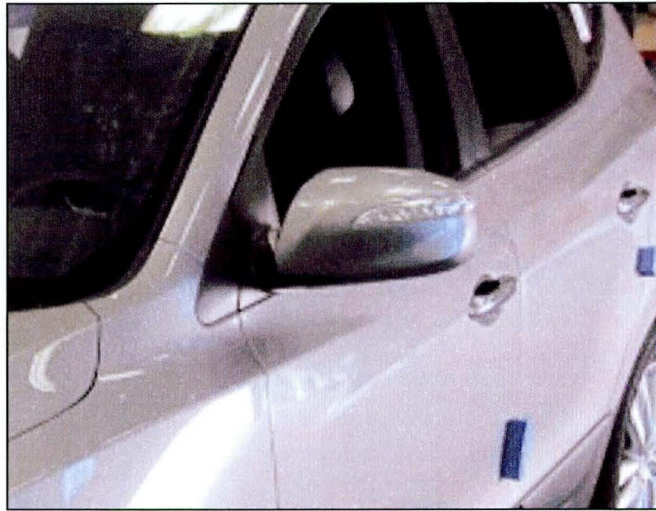
Description: Some Tucson (LM) may experience a sound from the left or right outside mirrors. This bulletin describes the procedure to add Loctite to the outside mirror base mounting screw.
