Excessive Wind Noise from Moon Roof when Open

Service Category Vehicle Exterior

Section Window/Glass

YEAR(S)	MODEL(S)	ADDITIONAL INFORMATION
2011 – 2012	tC

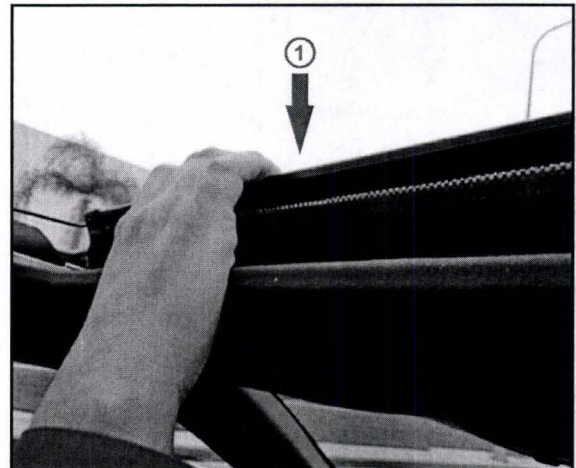
Figure 1.

- Confirm vehicle has excessive wind noise while driving at 45 mph with the moon roof in the "Full Open" position. If excessive wind noise is present, lower the fabric wind deflector ~20 mm (0.75 in.).
 - If wind noise decreases, proceed to step 2.
 - If wind noise does NOT decrease, this bulletin does not apply.
