ECM Calibration: Enhancement to Shifting Performance

Service Category Drivetrain

Section Automatic Transmission/Transaxle

YEAR(S)	MODEL(S)	ADDITIONAL INFORMATION
2008 – 2011	LX570	Transmission(s): 6AT VDS(s): HY00W, HY7AX

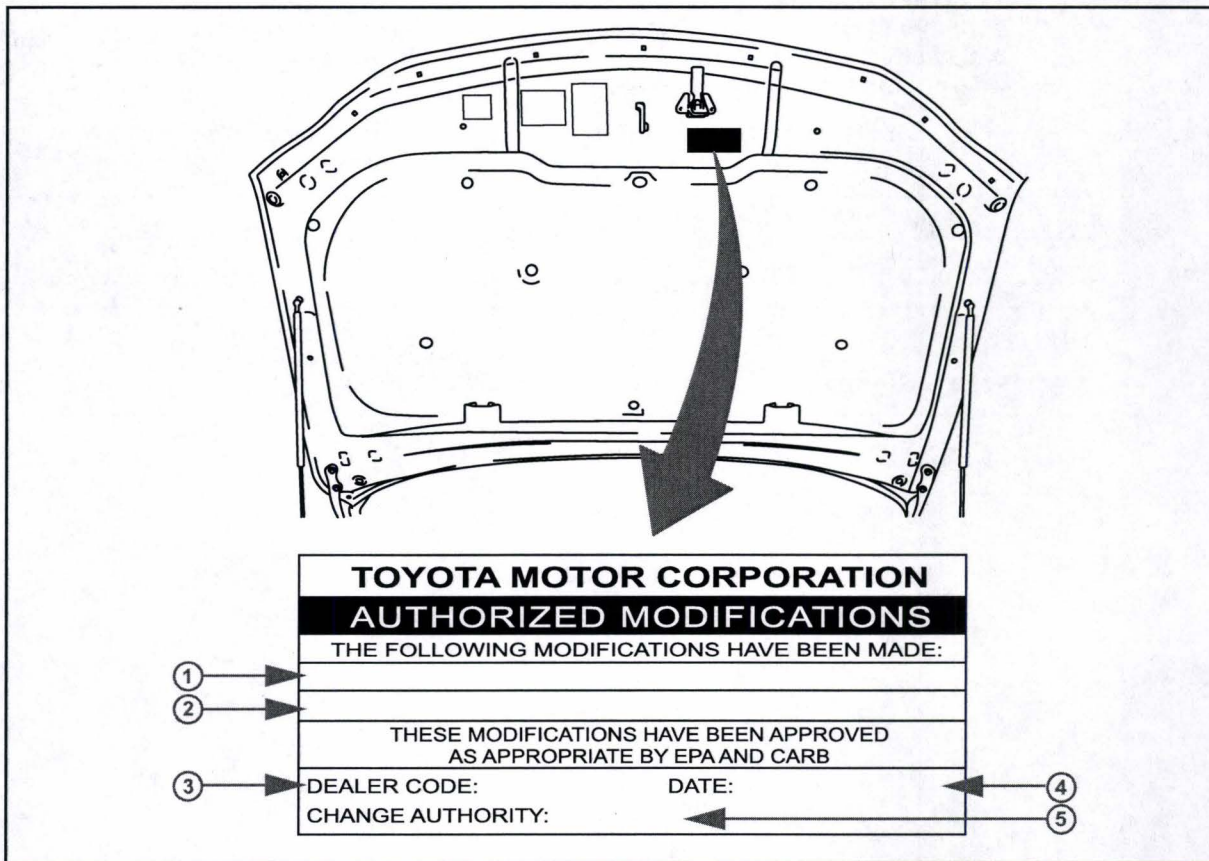
Figure 1. Location of Authorized Modifications Label on 2008 – 2011 LX 570

2. Check for the Authorized Modifications Label affixed to the vehicle in the location shown in Figure 1. Confirm if the ECM (PCM) calibration has been updated. If the calibration ID listed is NOT the latest ECM (PCM) calibration — go to step 3.

B. Affix the Authorized Modifications Label to the vehicle at the location shown in Figure 1. The Authorized Modifications Label is available through the MDC, P/N 00451-00001-LBL.
