Safety Connect Volume Improvement

Service Category Audio/Visual/Telematics

Market USA

YEAR(S)	MODEL(S)	ADDITIONAL INFORMATION
2012	Prius PHV	
2012	Prius

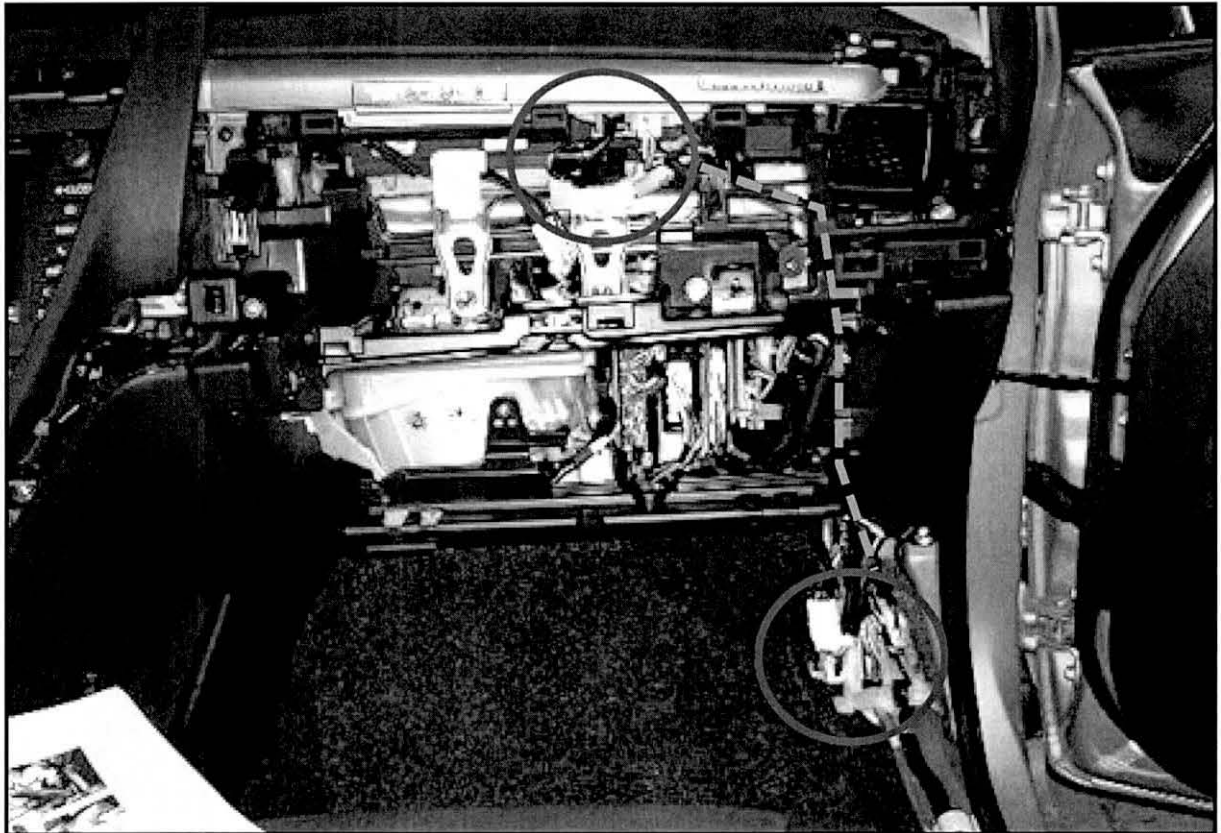
Figure 13.

11. Follow the next steps to install the NEW sub-wire harness. Highlighted (green) line shows the approximate route of the new sub-wire harness. The (red) circles show the location of connectors LI1 and NL2.

- A. Disconnect connector LI1. Install both connectors from the new sub-wire harness into both sections of connector LI1.
