T-SB-0230-12

November 27, 2012

Air Injection System MIL "ON"

Some 2005 – 2009 model year 4Runner, 2006 – 2007 model year Land Cruiser, 2005 – 2007 model year Sequoia, and 2005 – 2006 model year Tundra vehicles equipped with the 2UZ-FE (4.7 L) engine may exhibit a MIL "ON" condition for the following Diagnostic Trouble Codes (DTCs):

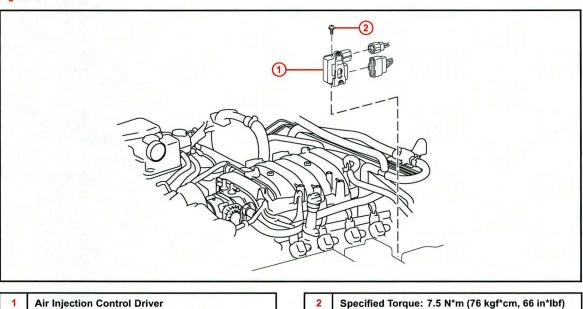
Figure 1.

- If MIL illuminates, or a DTC is detected, proceed to step 6.
- If MIL does not illuminate, or a DTC is not detected, proceed to step 8.
- 6. Using Techstream, check for DTCs. If P0418 and/or P2445 are present, replace the Air Injection Control Driver.
