ECM Calibration: Enhancement to Shifting Performance

Service
Category Drivetrain

Section Automatic Transmission/Transaxle

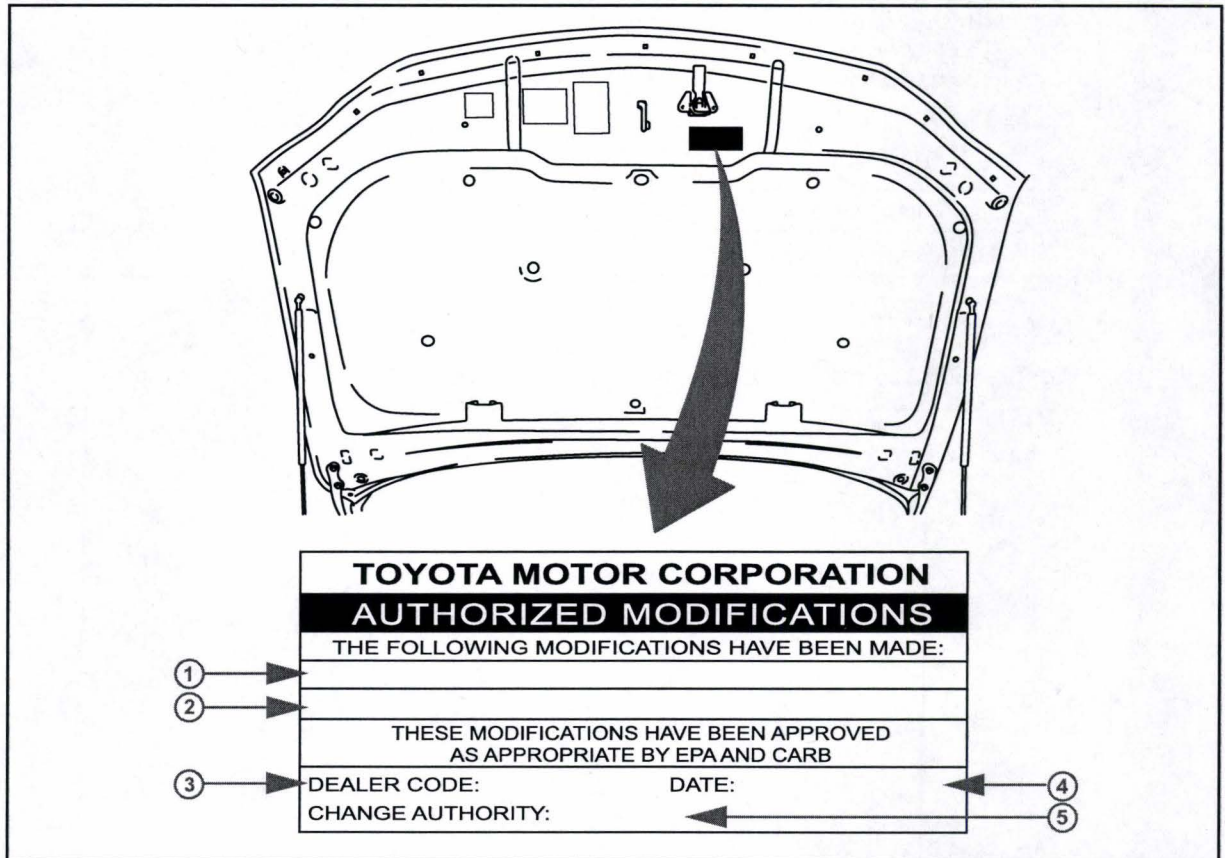
Figure 1. Location of Authorized Modifications Label on 2008 – 2011 Land Cruiser

2. Check for the Authorized Modifications Label affixed to the vehicle in the location shown in Figure 1. Confirm if the ECM (PCM) calibration has been updated. If the calibration ID listed is NOT the latest ECM (PCM) calibration — go to step 3.

B. Affix the Authorized Modifications Label to the vehicle at the location shown in Figure 1. The Authorized Modifications Label is available through the MDC, P/N 00451-00001-LBL.
