MIL "ON" DTC P219A or P219B (2GR-FE)

Service Category Engine/Hybrid System

Section Engine Control

Some 2012 – 2013 model year Camry and 2012 model year Venza vehicles equipped with 2GR-FE engines may exhibit a MIL "ON" condition with Diagnostic Trouble Code (DTC) P219A or P219B present. The Engine Control Module/ECM (SAE term: Powertrain Control Module/PCM) logic has been modified to reduce the possibility of this condition occurring. Please follow the repair procedure below to address this condition.

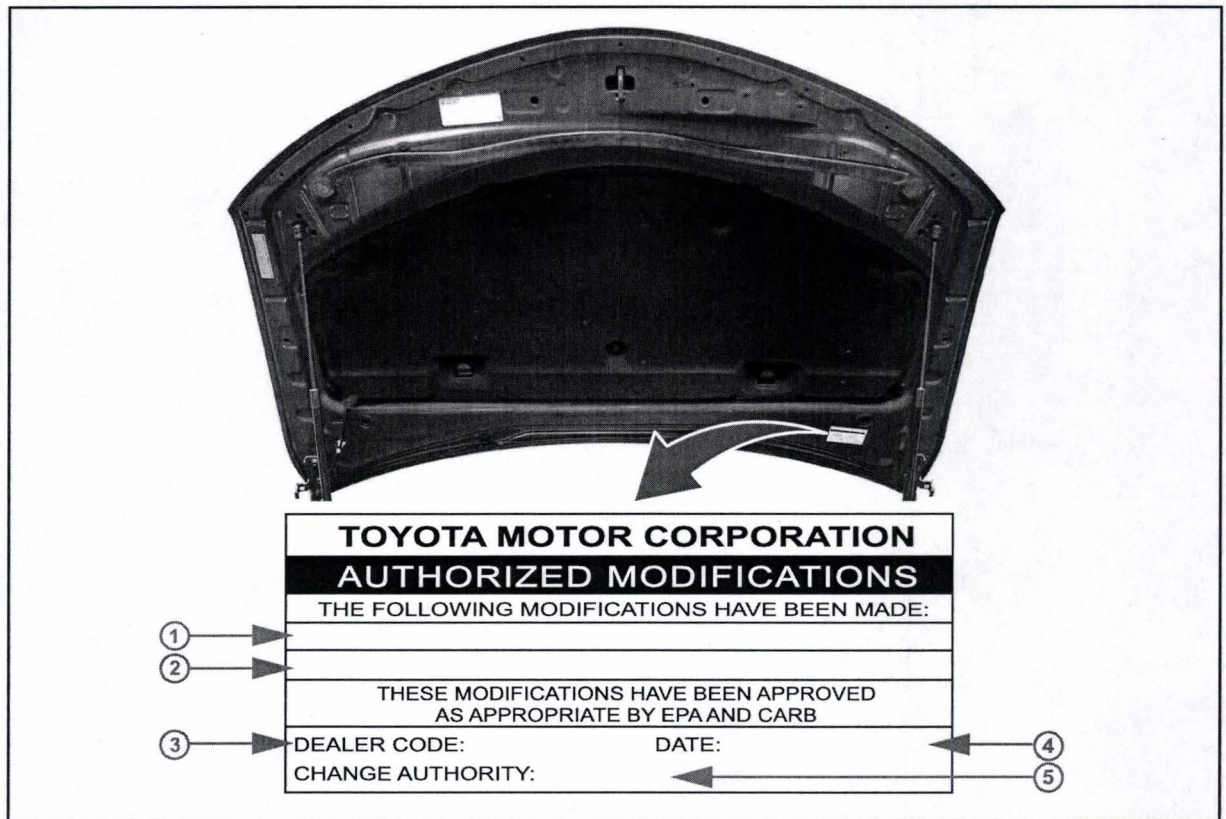
Figure 1. Location of Authorized Modifications Label on 2012 – 2013 Camry

1	Replacement ECM (PCM) Part Number (i.e., 89661-06K42)
2	New Calibration ID(s) (i.e., 30677200)
3	Dealer Code

4	Date Completed
5	This SB Number

2. Check for the Authorized Modifications Label affixed to the vehicle in the location shown in Figures 1 and 2. Confirm if the ECM (PCM) calibration has been updated. If the calibration ID listed is NOT the latest ECM (PCM) calibration — go to step 3.

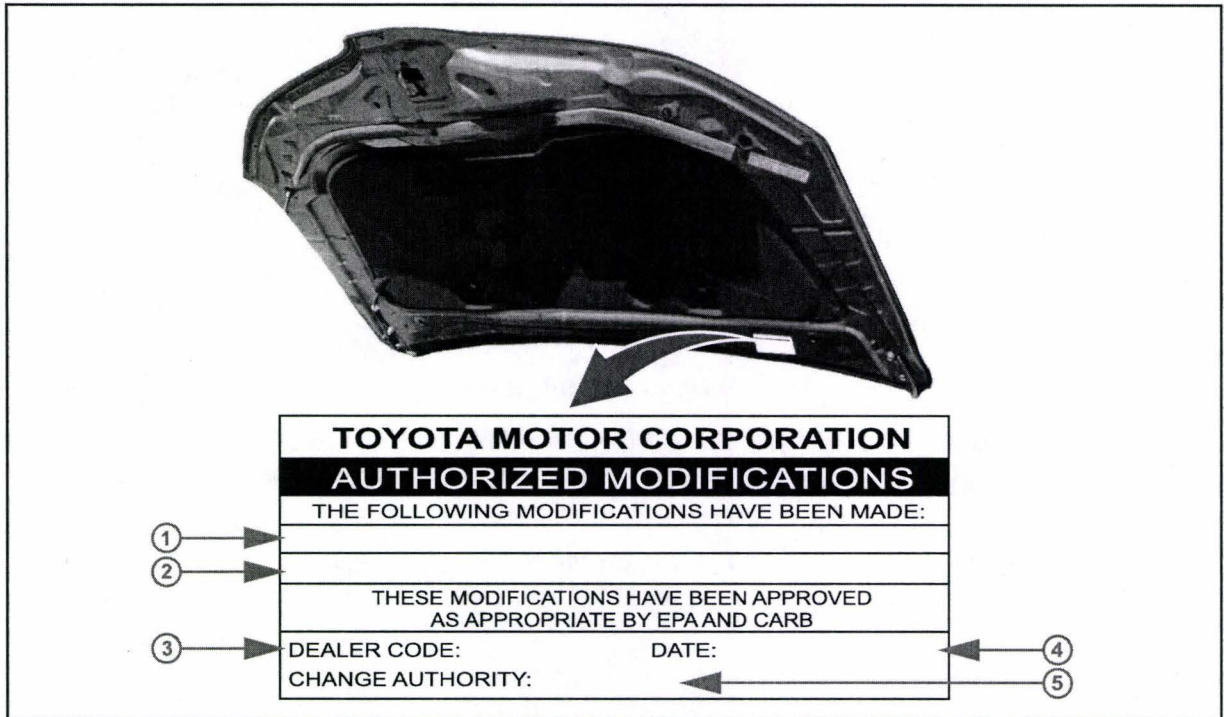
Figure 2. Location of Authorized Modifications Label on 2012 Venza

1	Replacement ECM (PCM) Part Number (i.e., 89661-JT091)
2	New Calibration ID(s) (i.e., 30T05100)
3	Dealer Code

4	Date Completed
5	This SB Number
